## **APPENDIX B: DETAILED NOISE MEASUREMENT RESULTS**

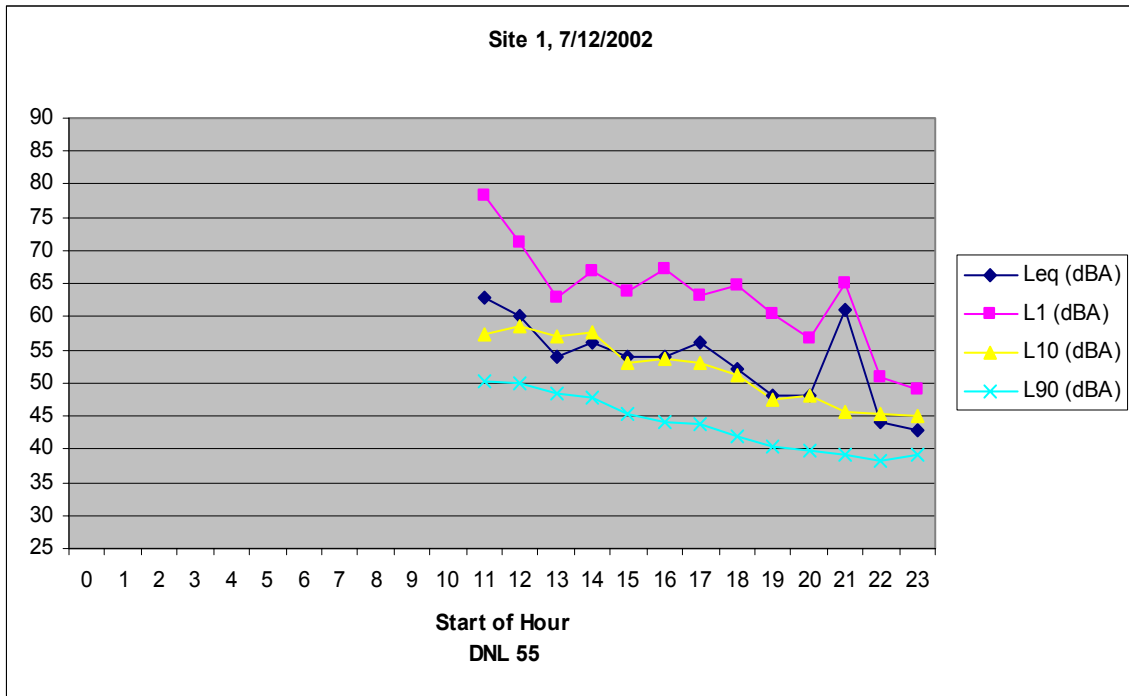
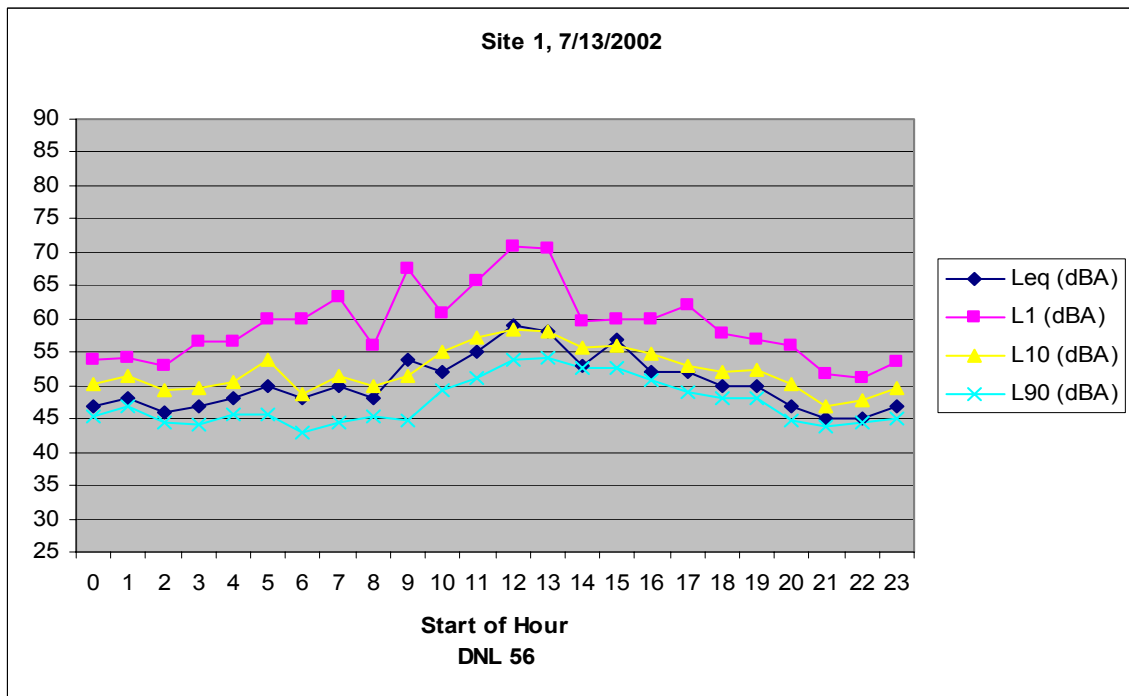
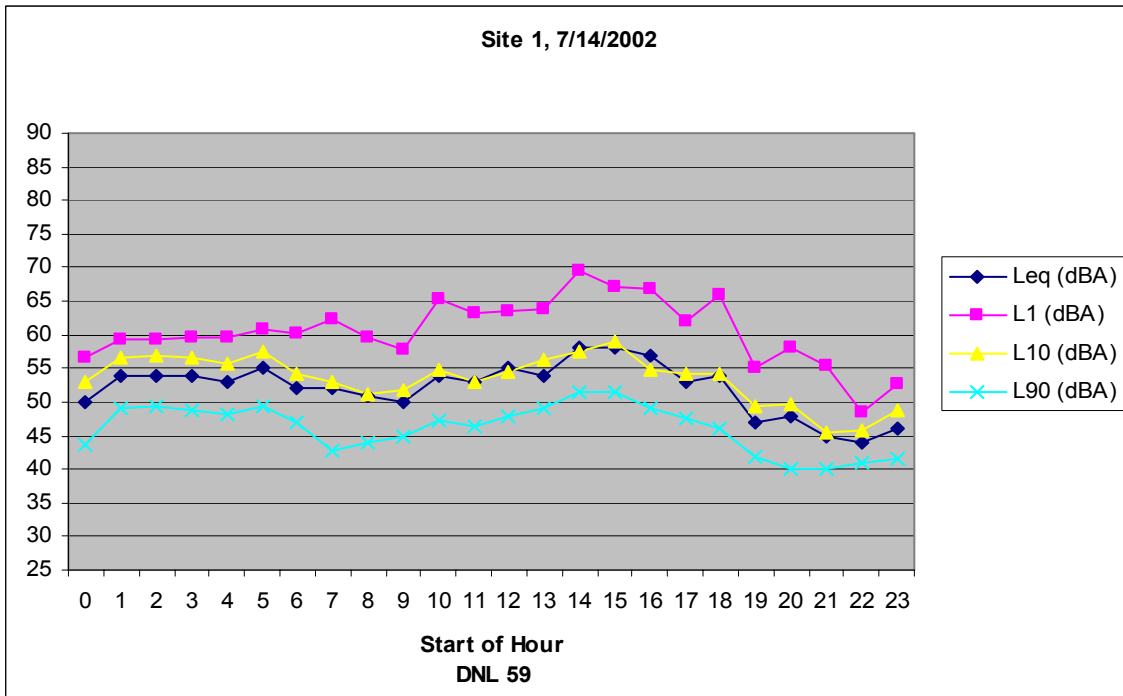
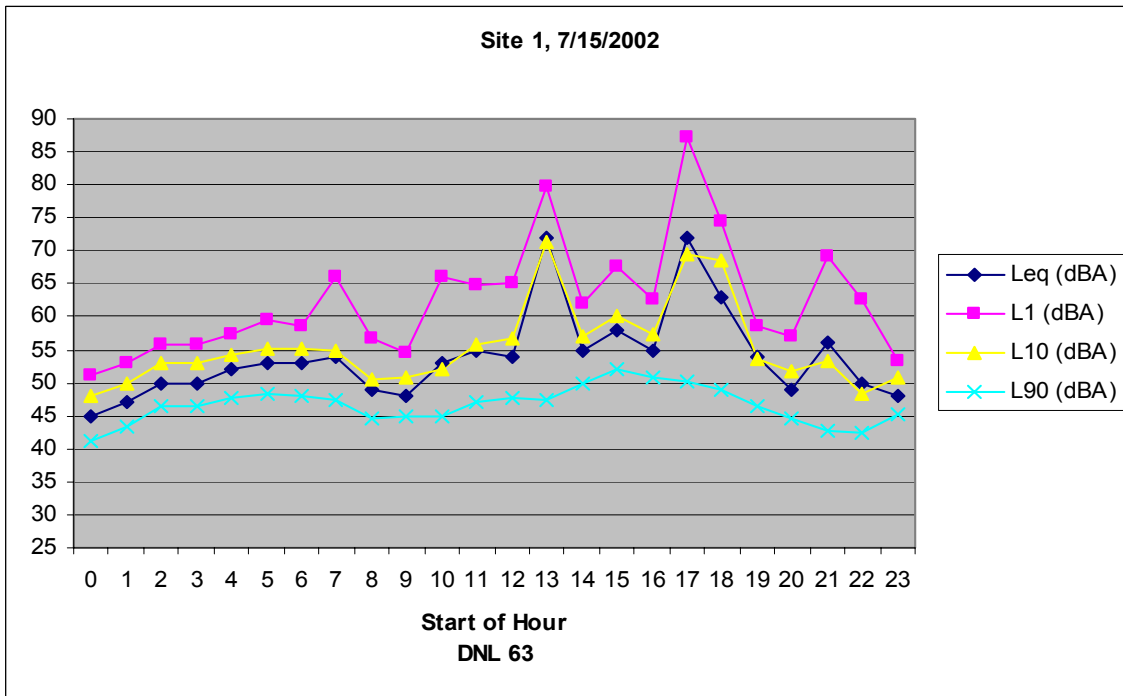
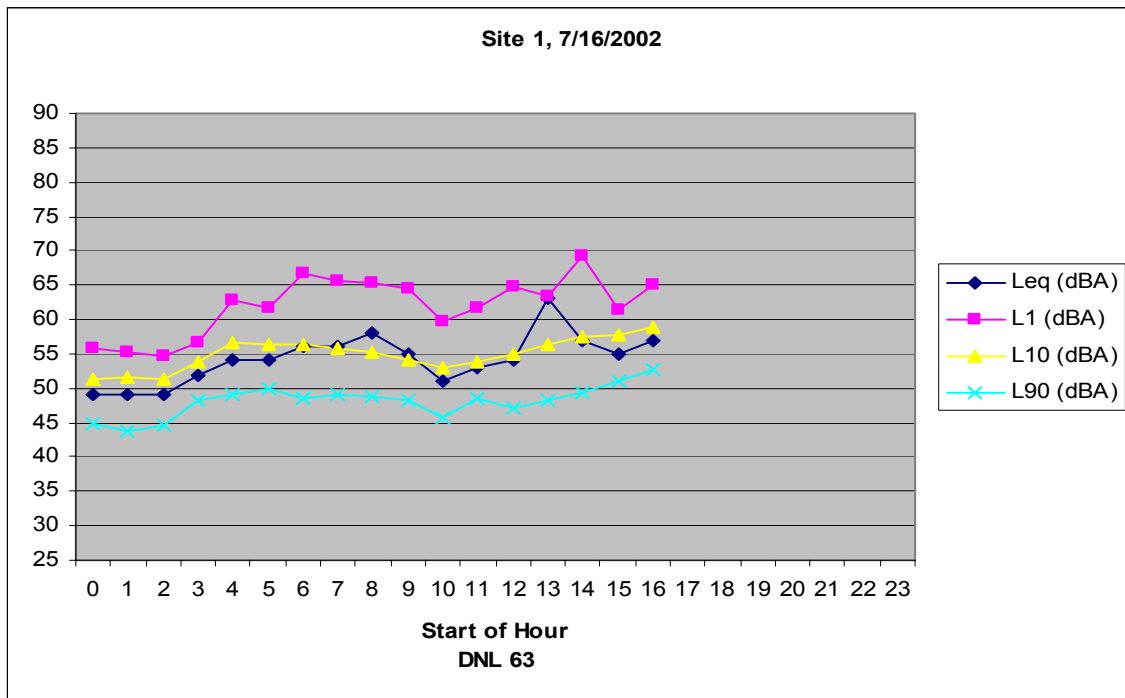
**Figure B-1 Measured Hourly Noise Levels, Site 1**

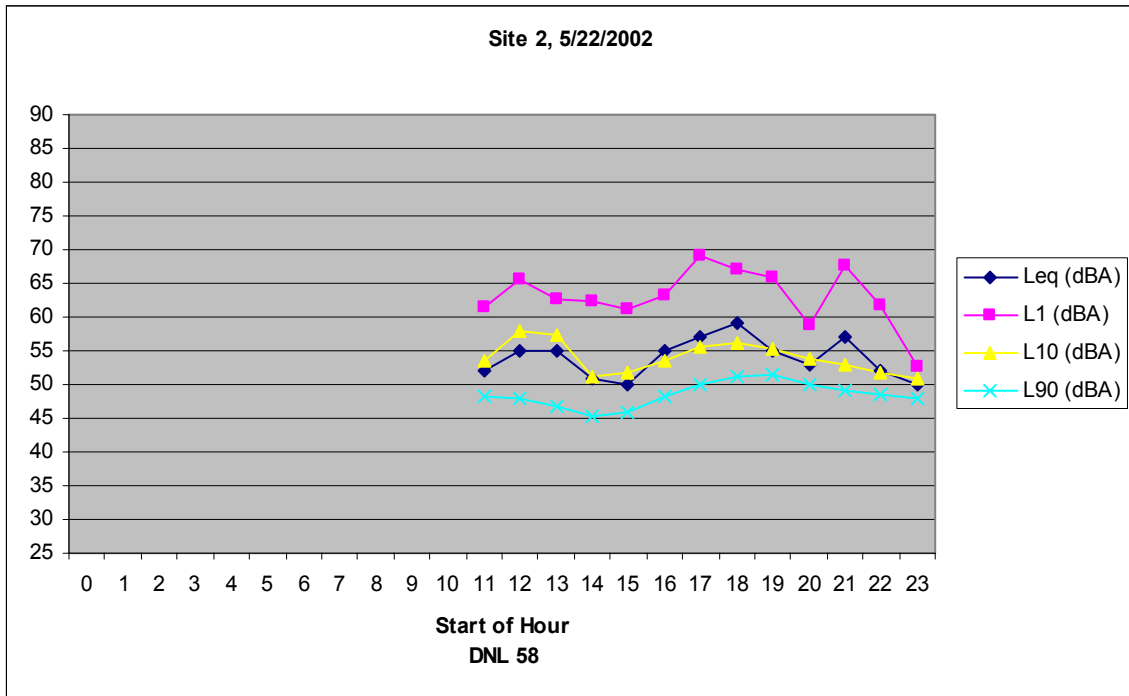
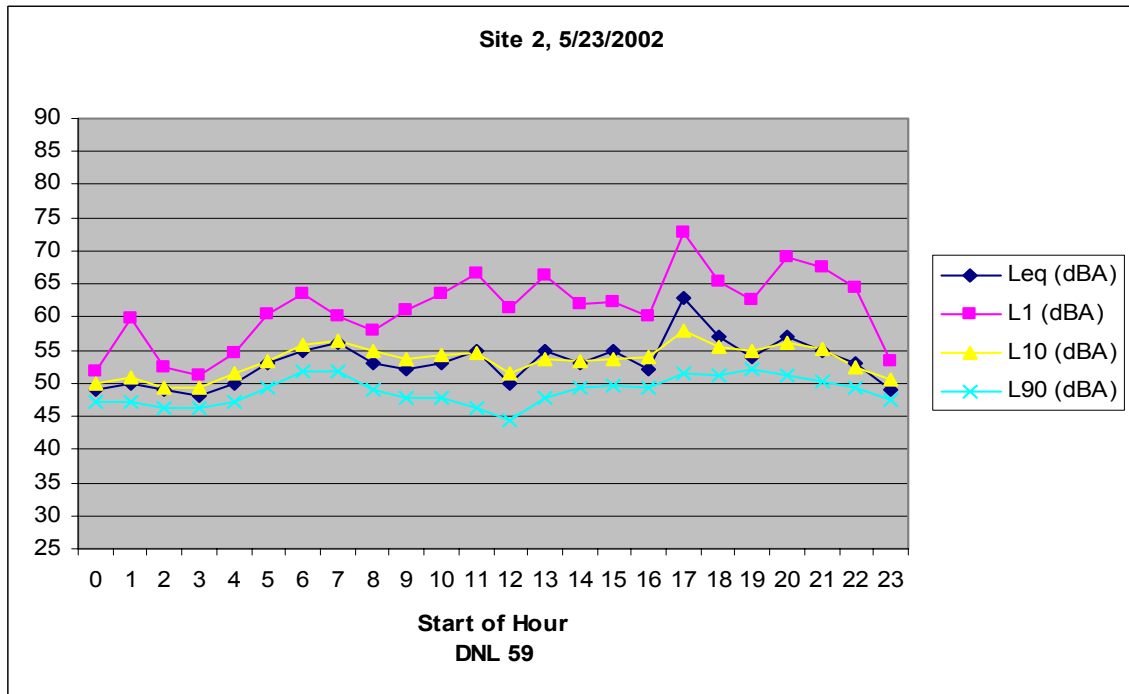
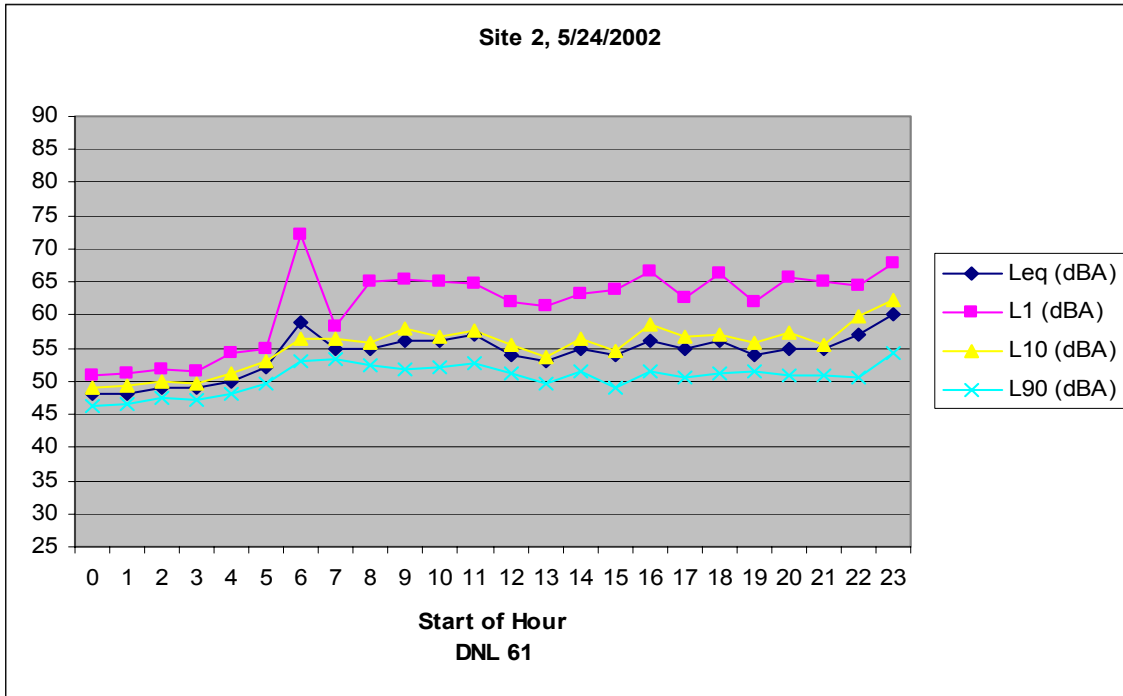
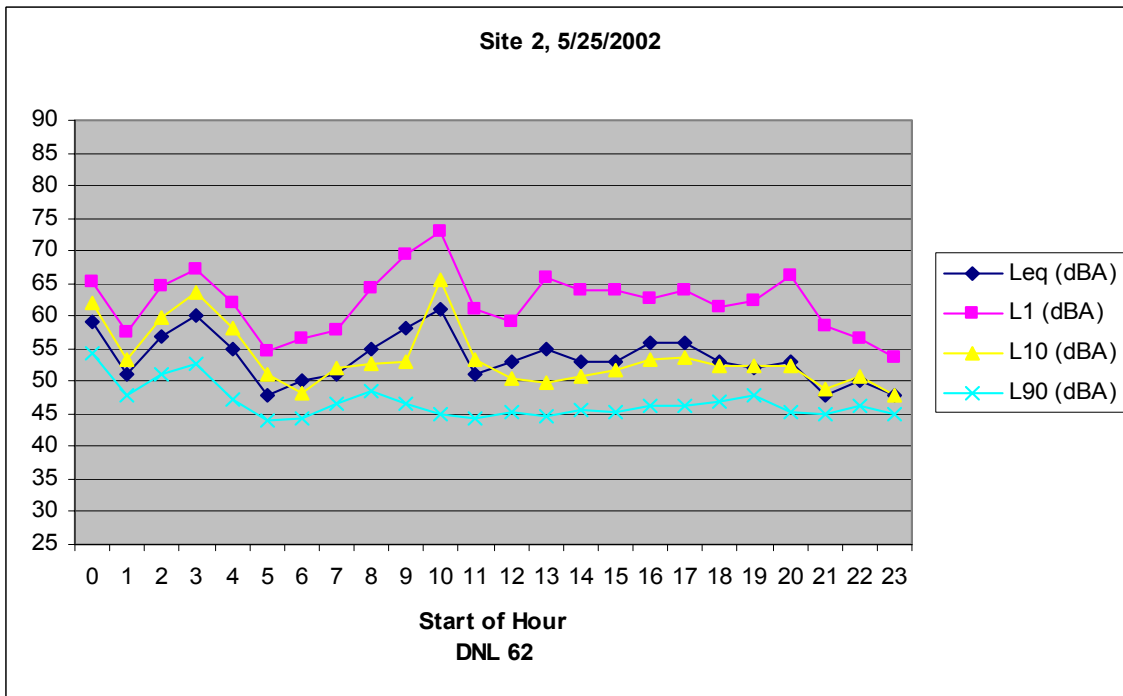
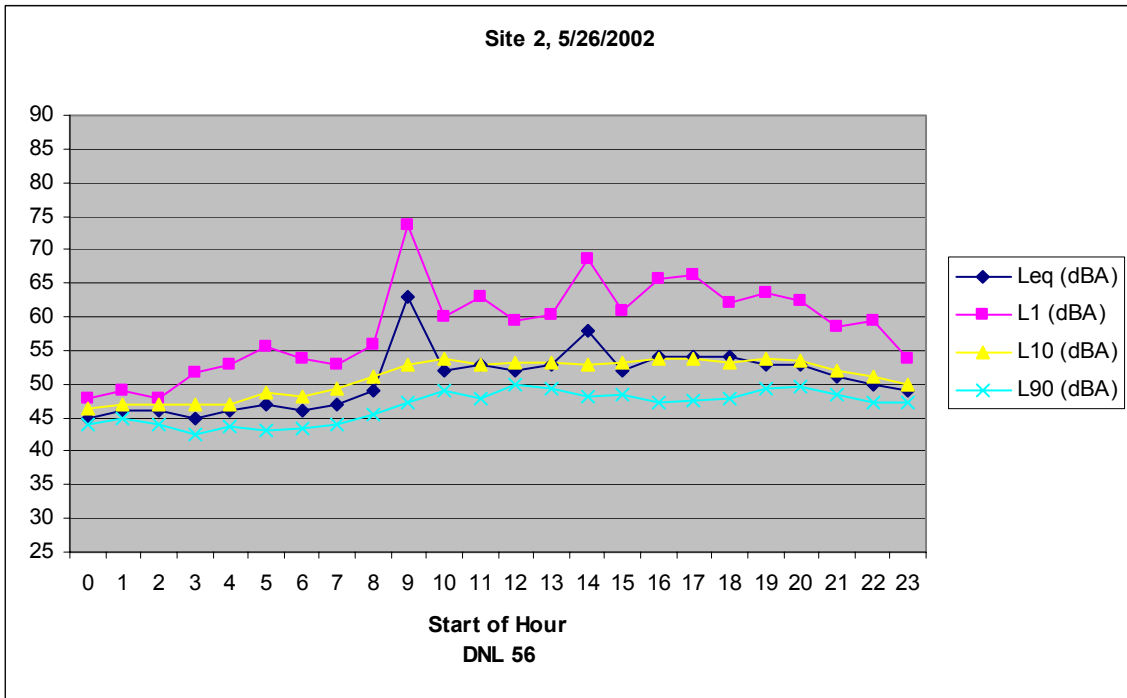
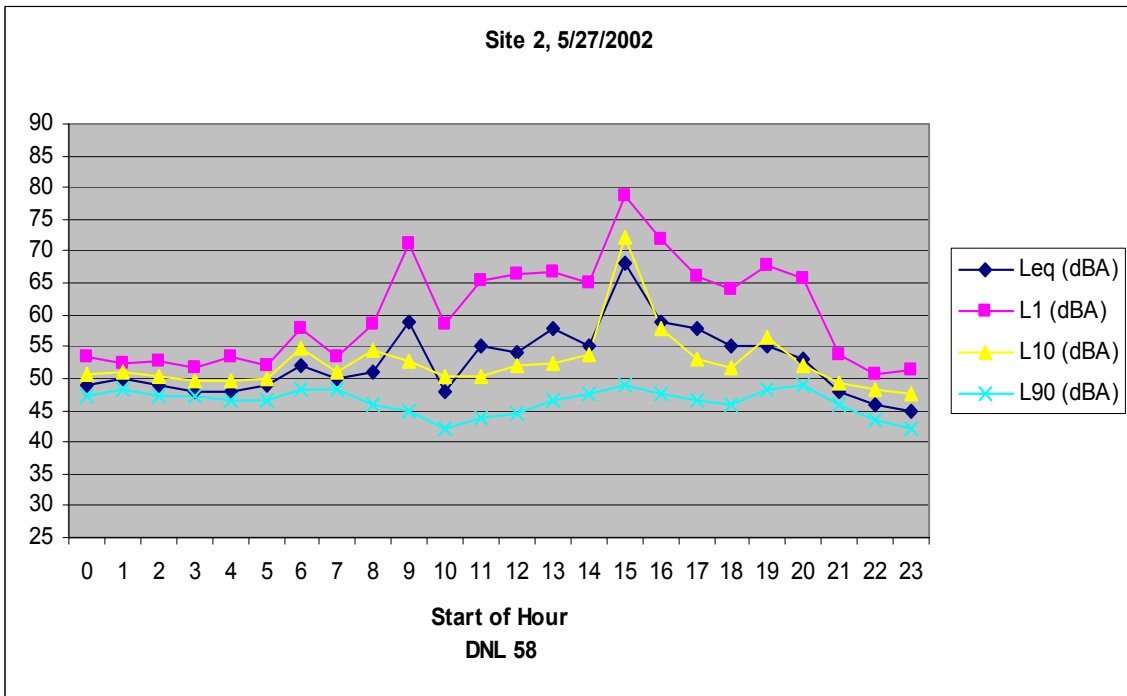
**Figure B-2 Measured Hourly Noise Levels, Site 2**

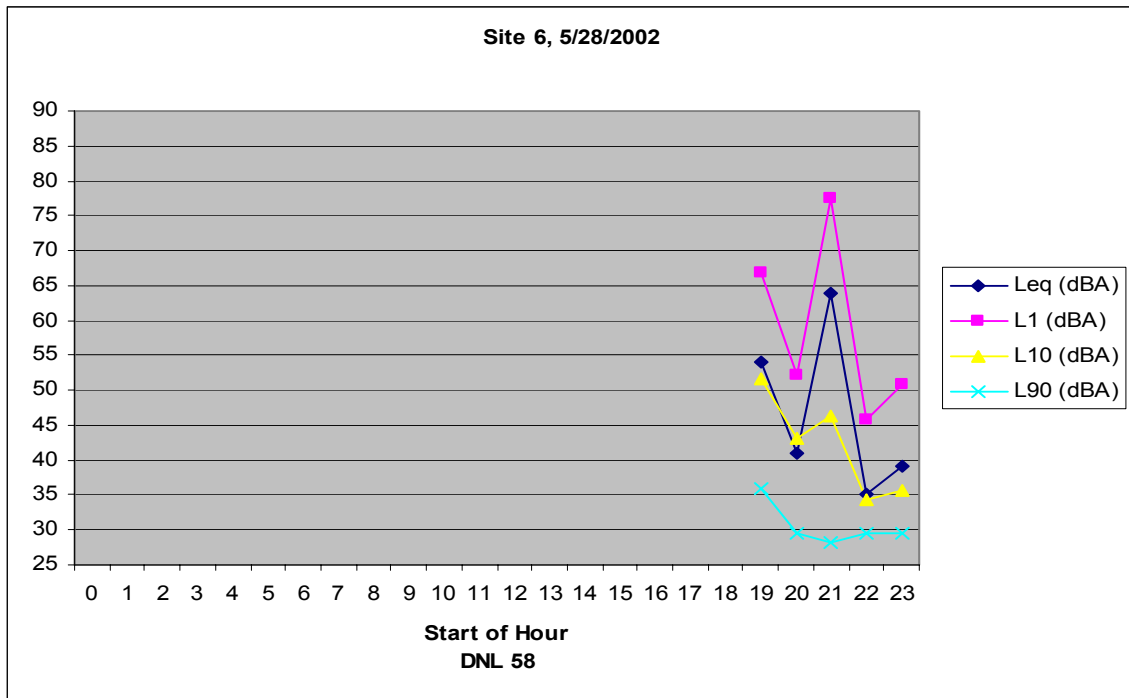
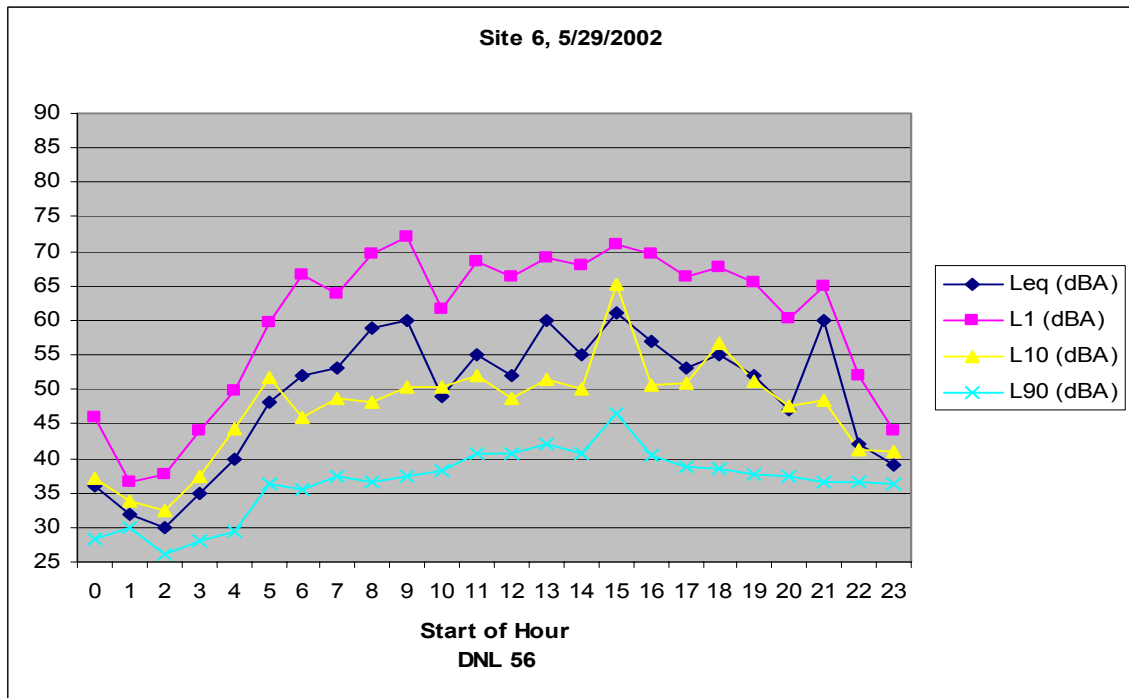
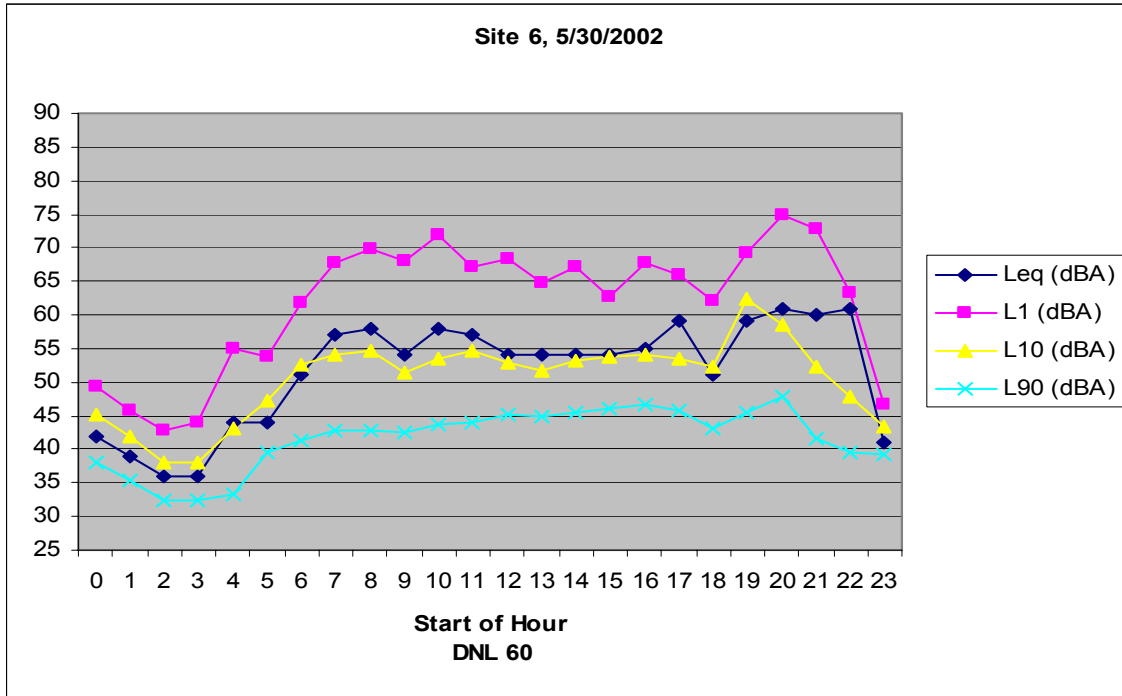
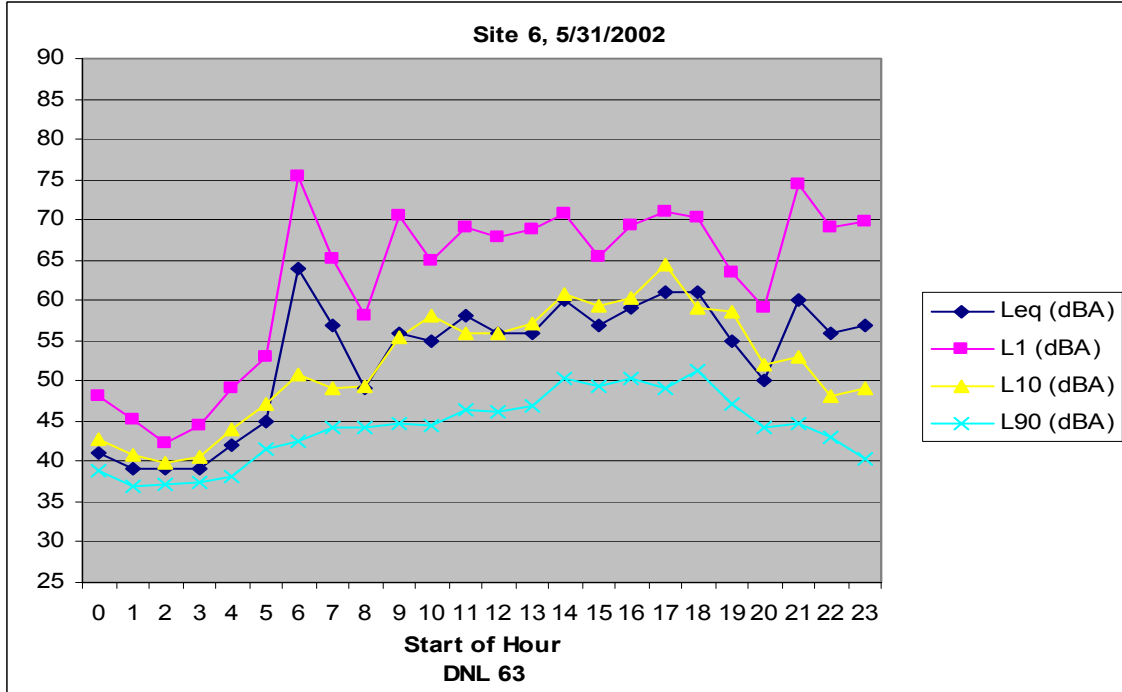
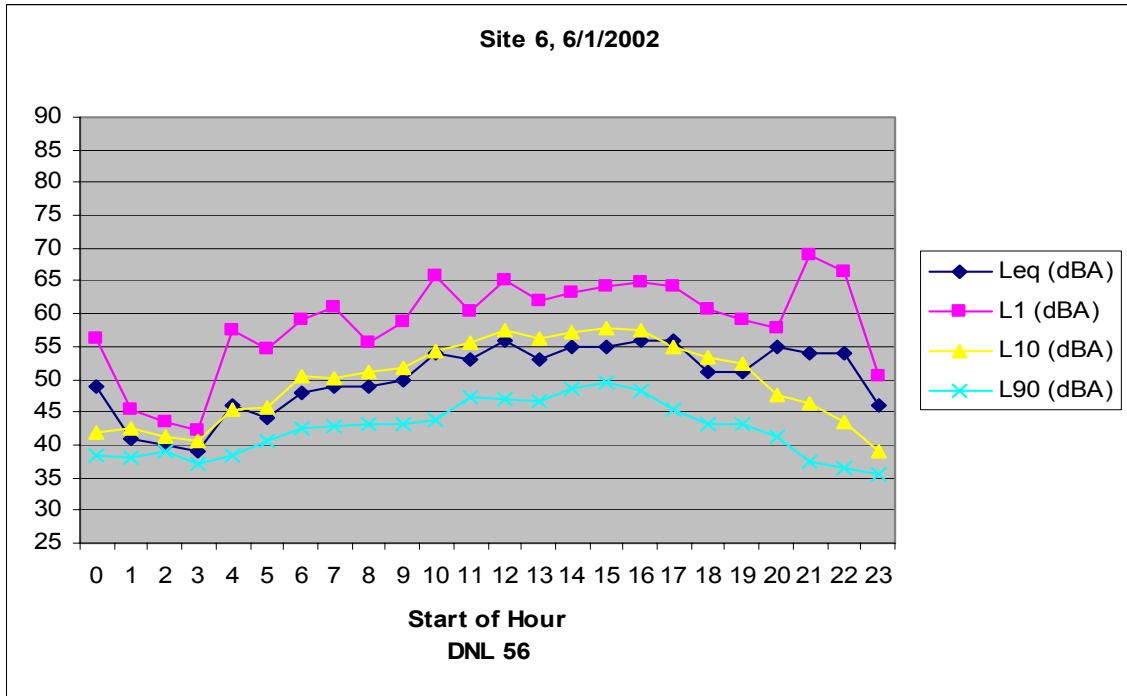
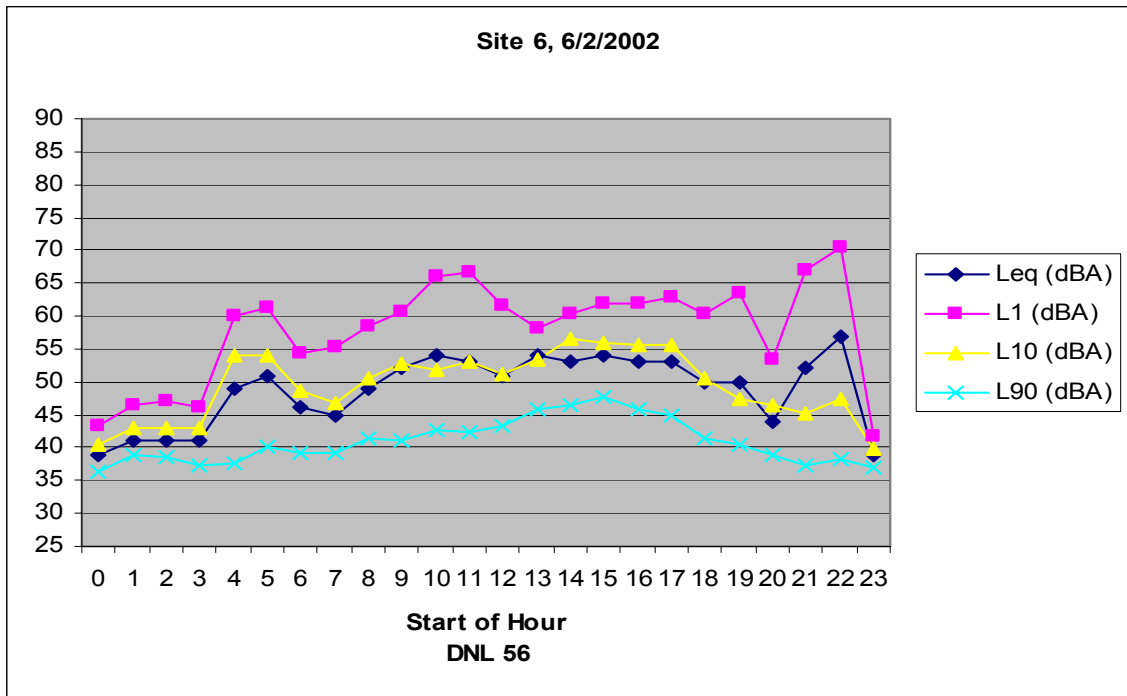
**Figure B-3 Measured Hourly Noise Levels, Site 6**

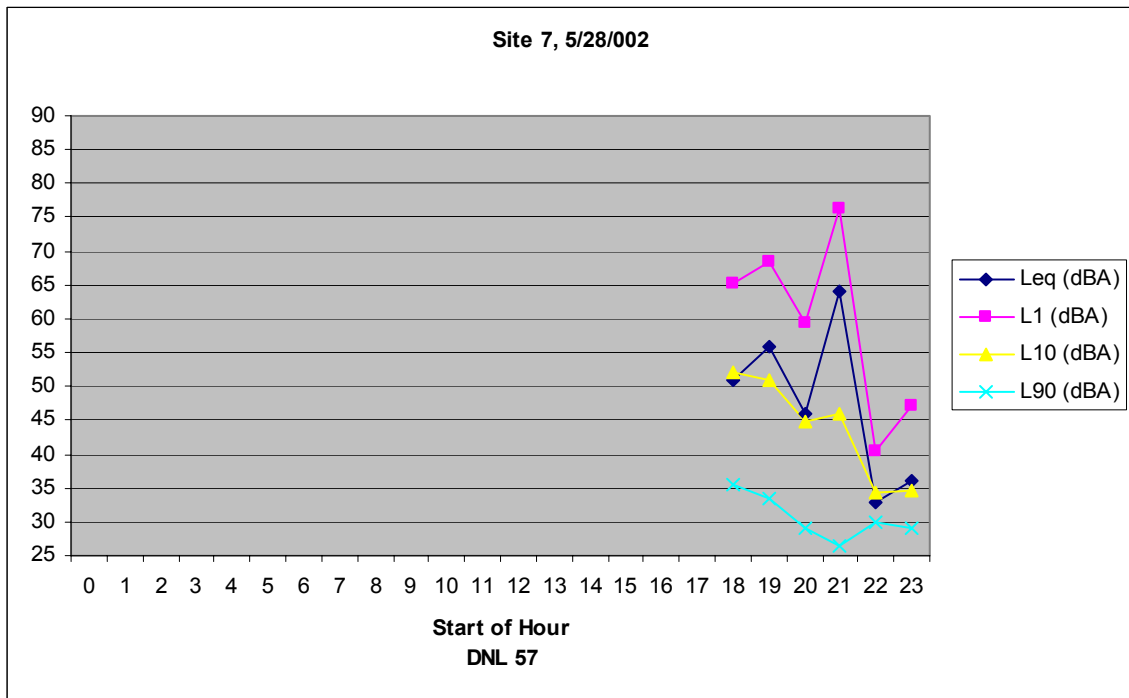
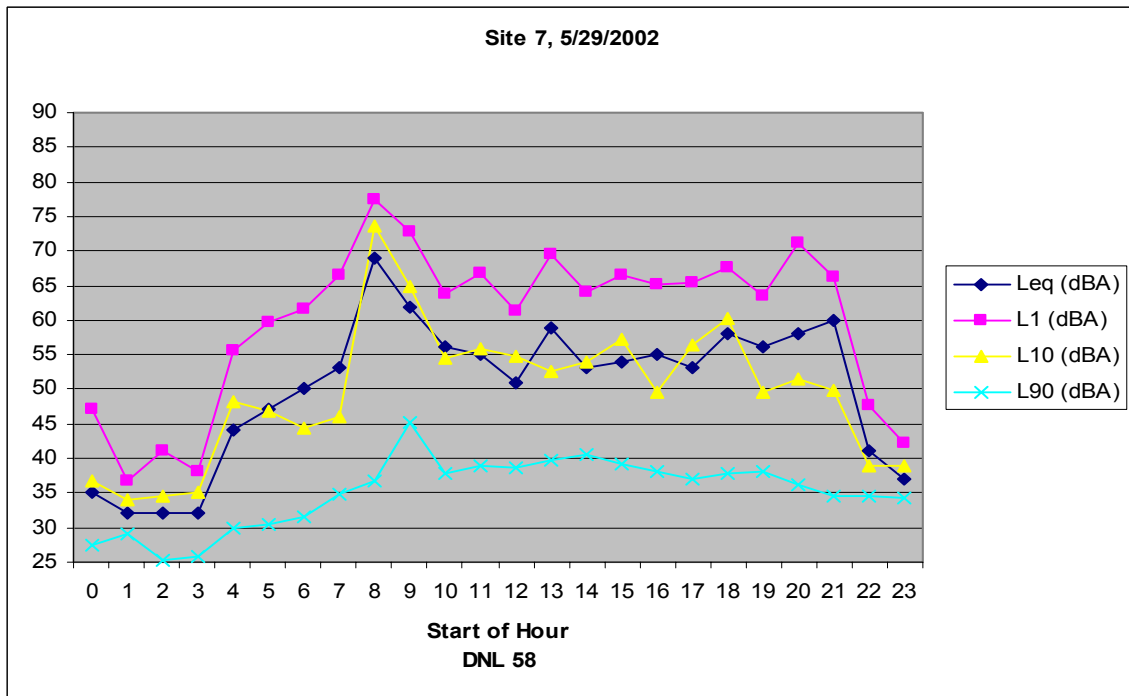
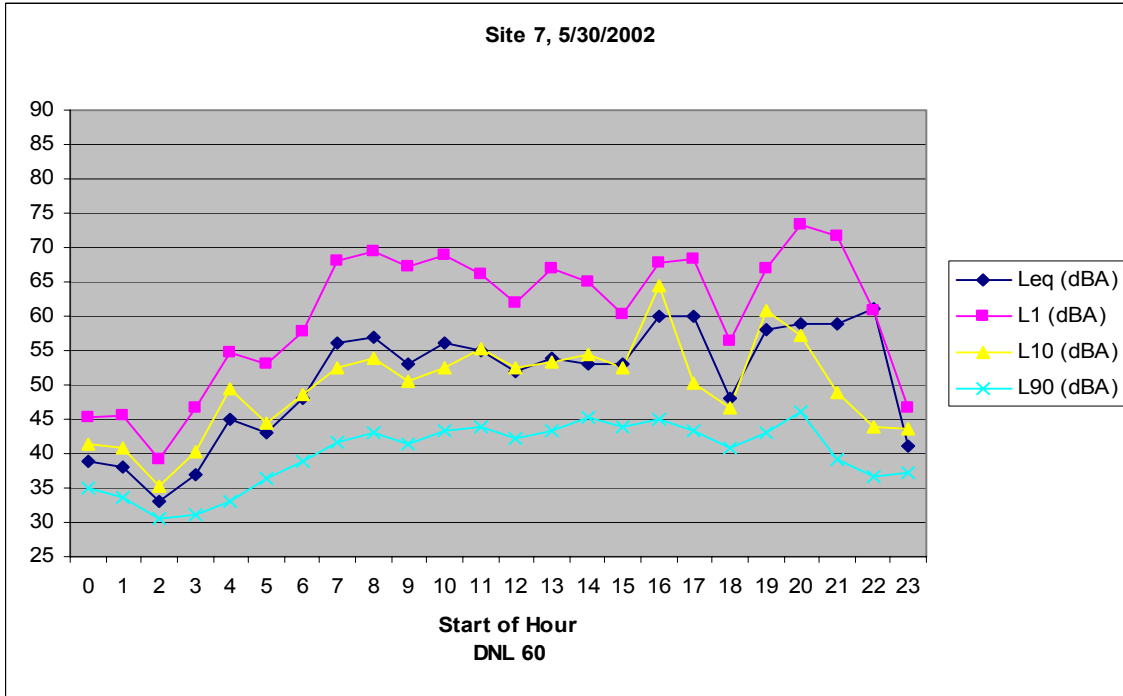
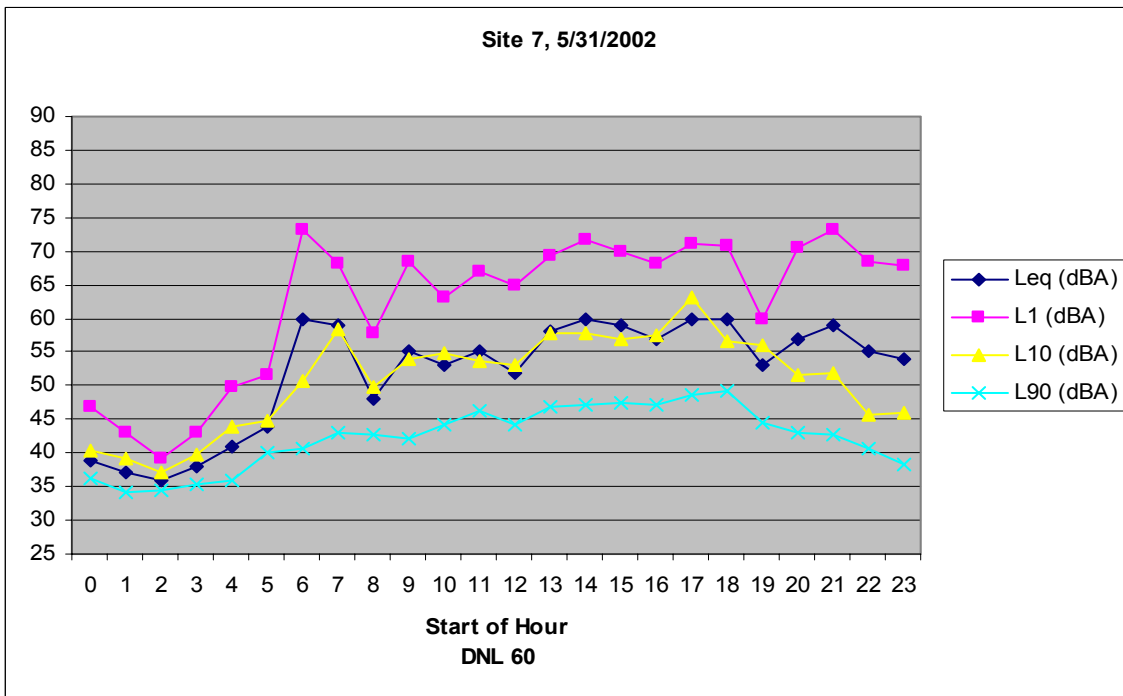
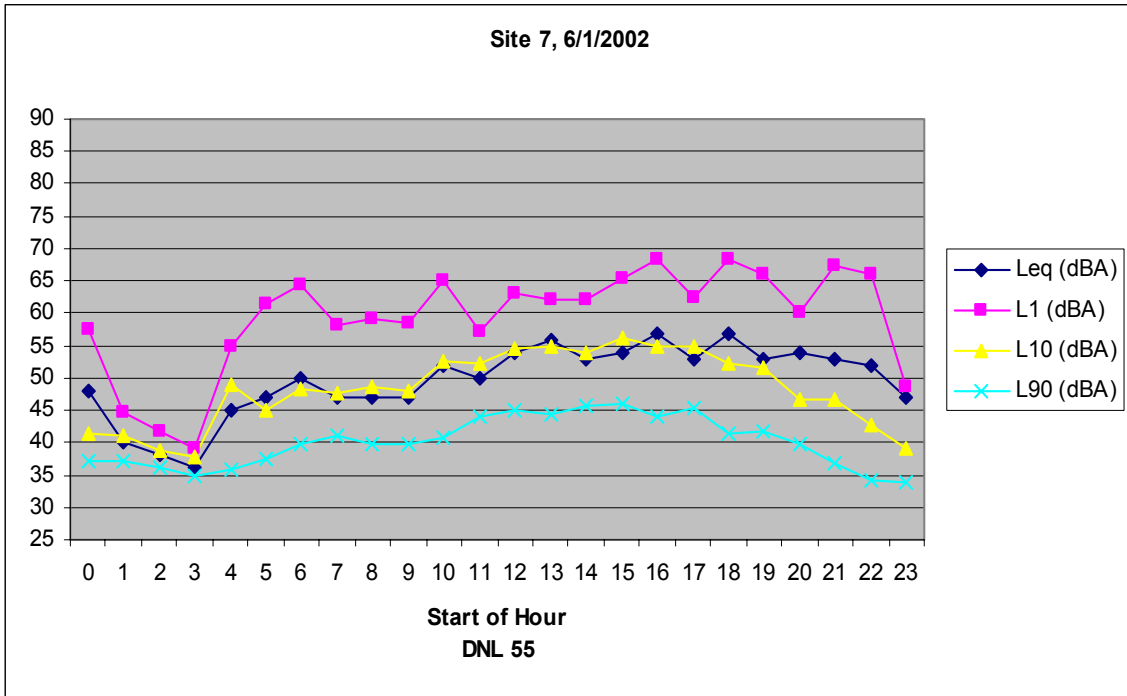
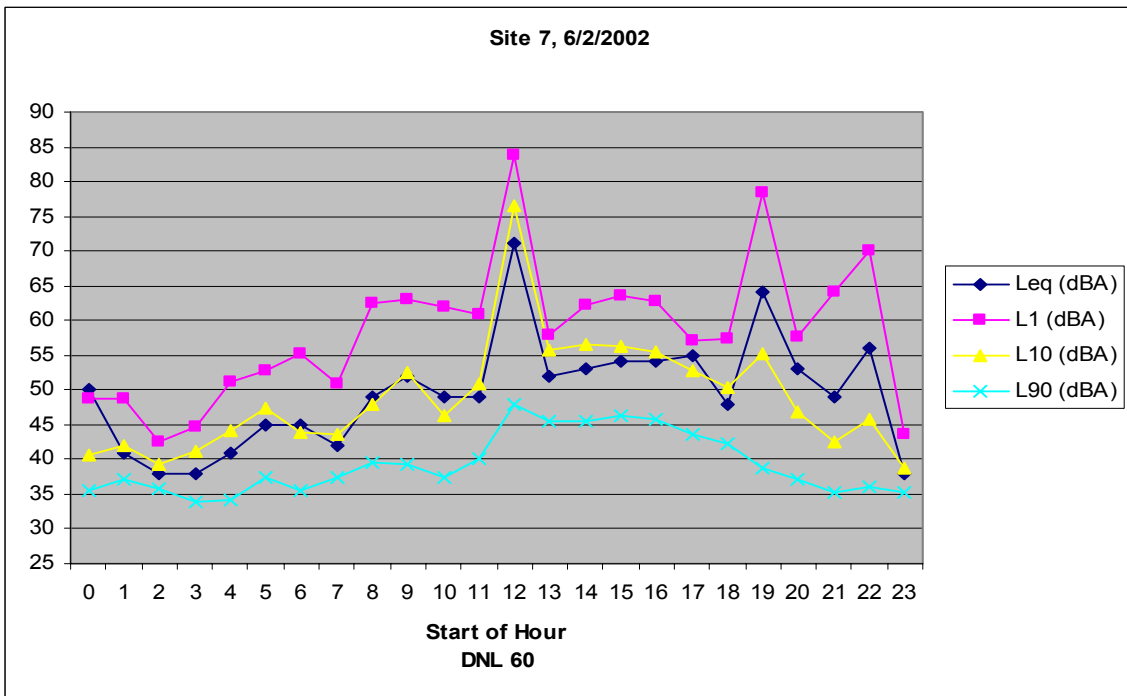
**Figure B-4 Measured Hourly Noise Levels, Site 7**

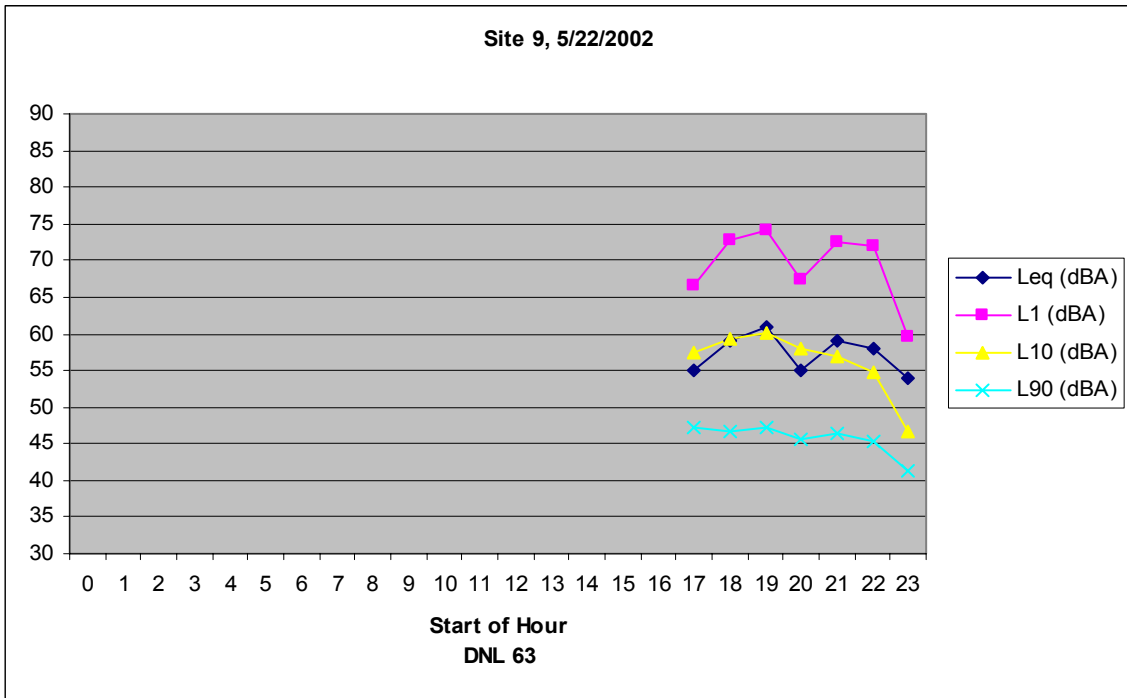
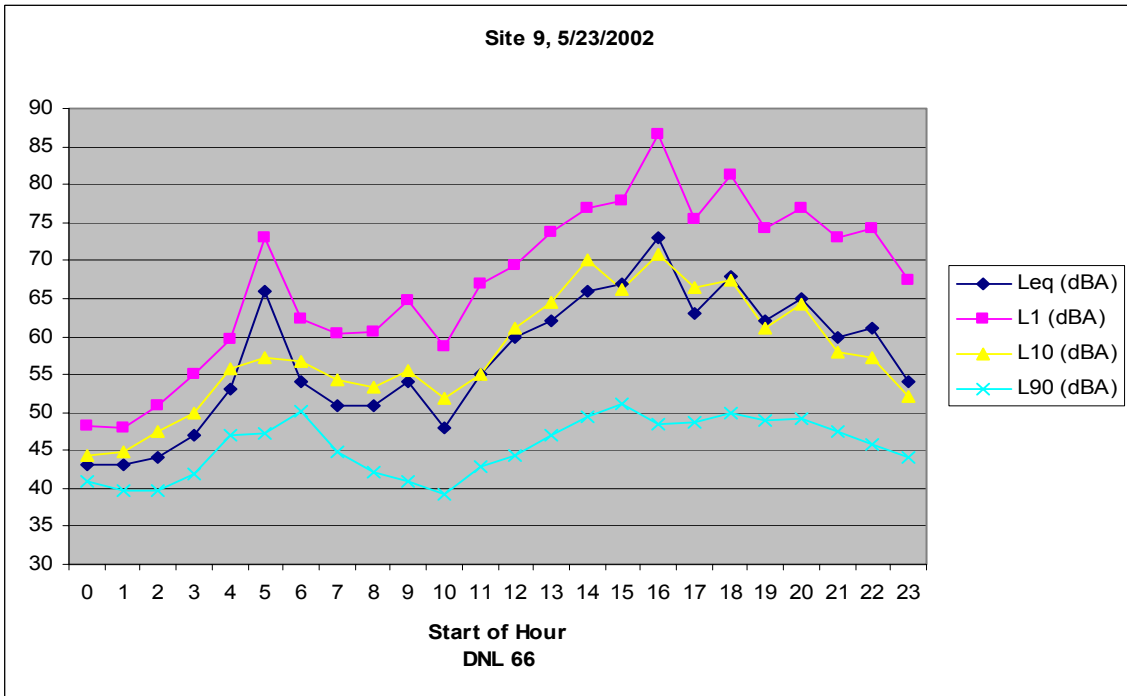
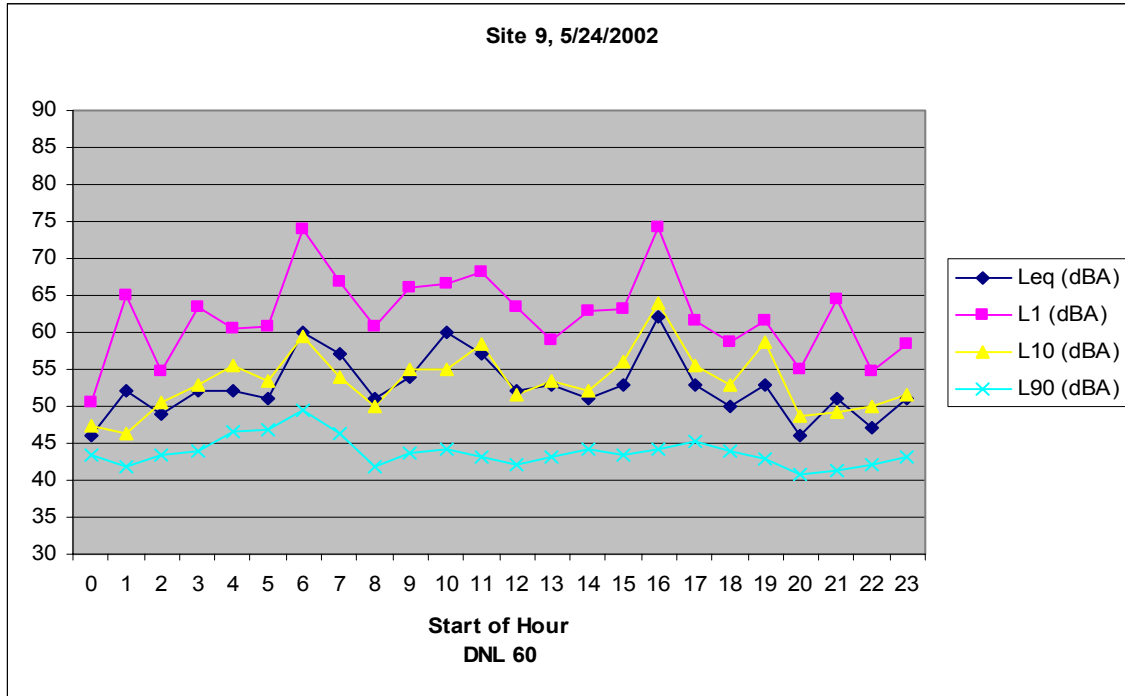
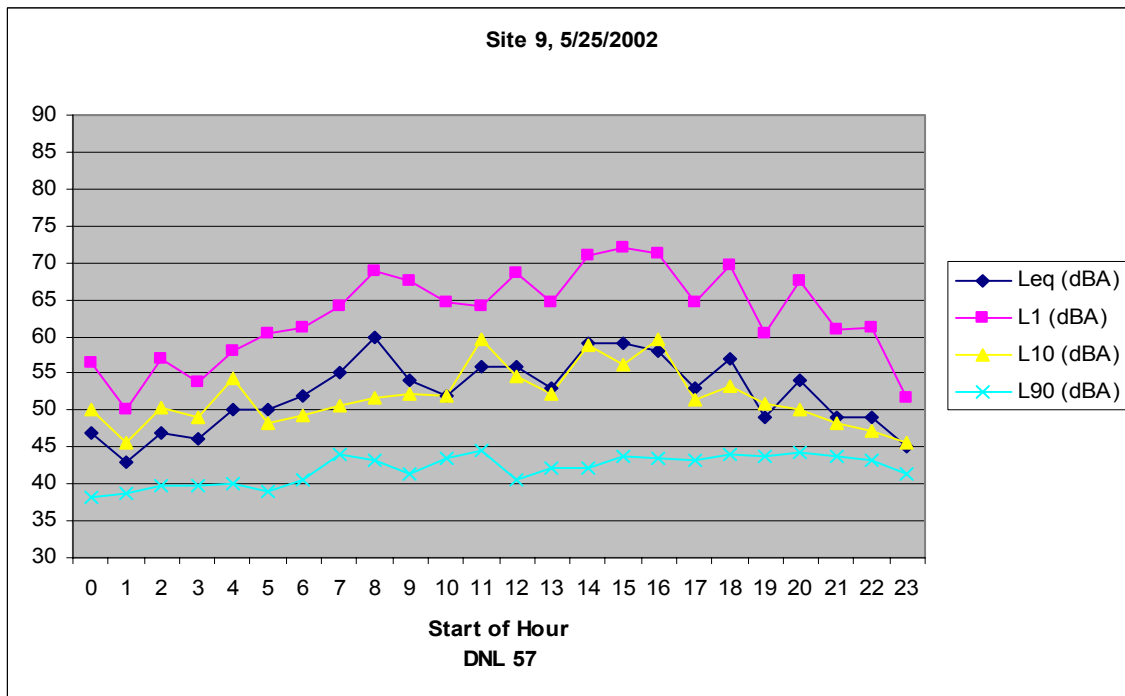
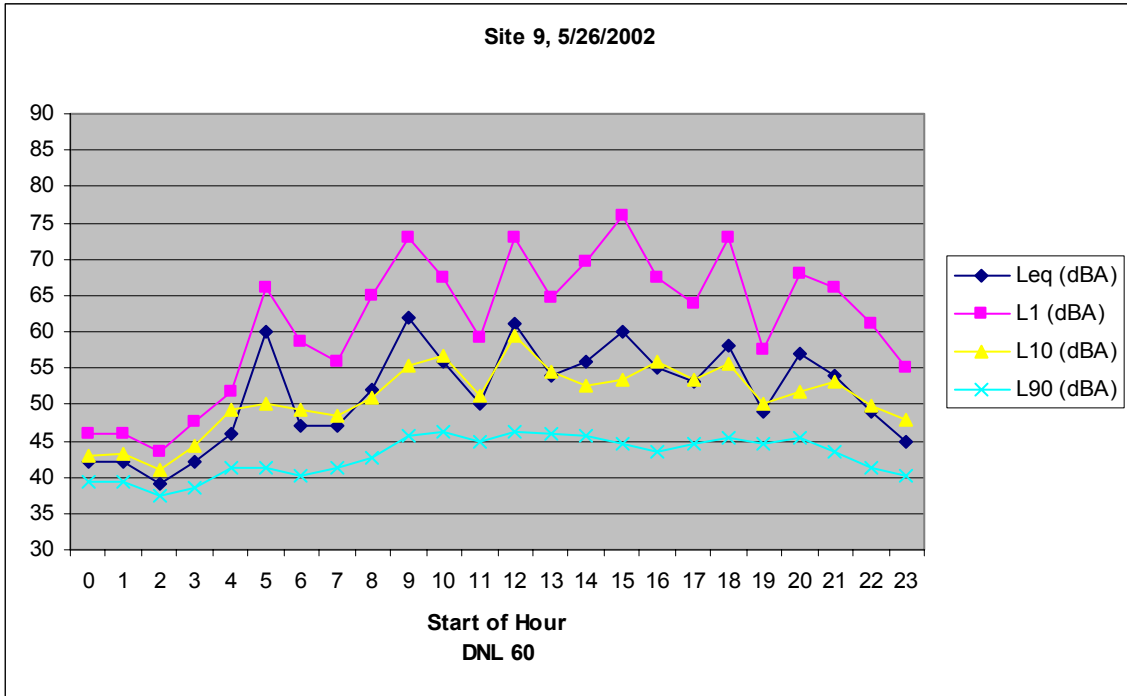
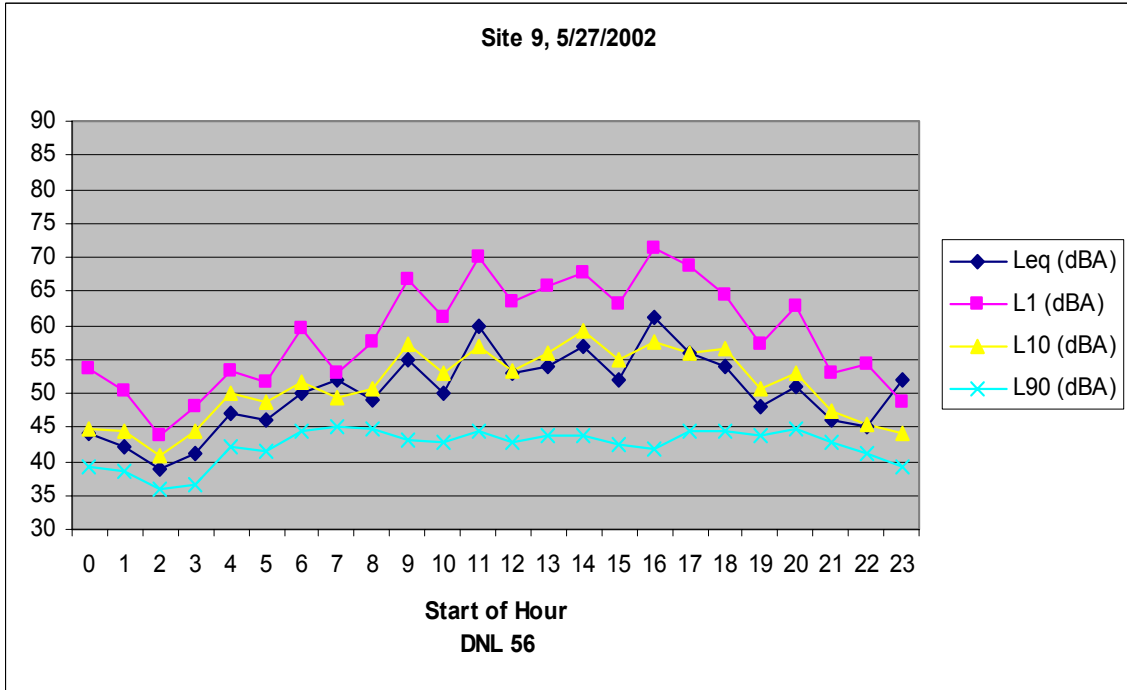
**Figure B-5 Measured Hourly Noise Levels, Site 9**
