## **APPENDIX B: DETAILED NOISE MEASUREMENT RESULTS**

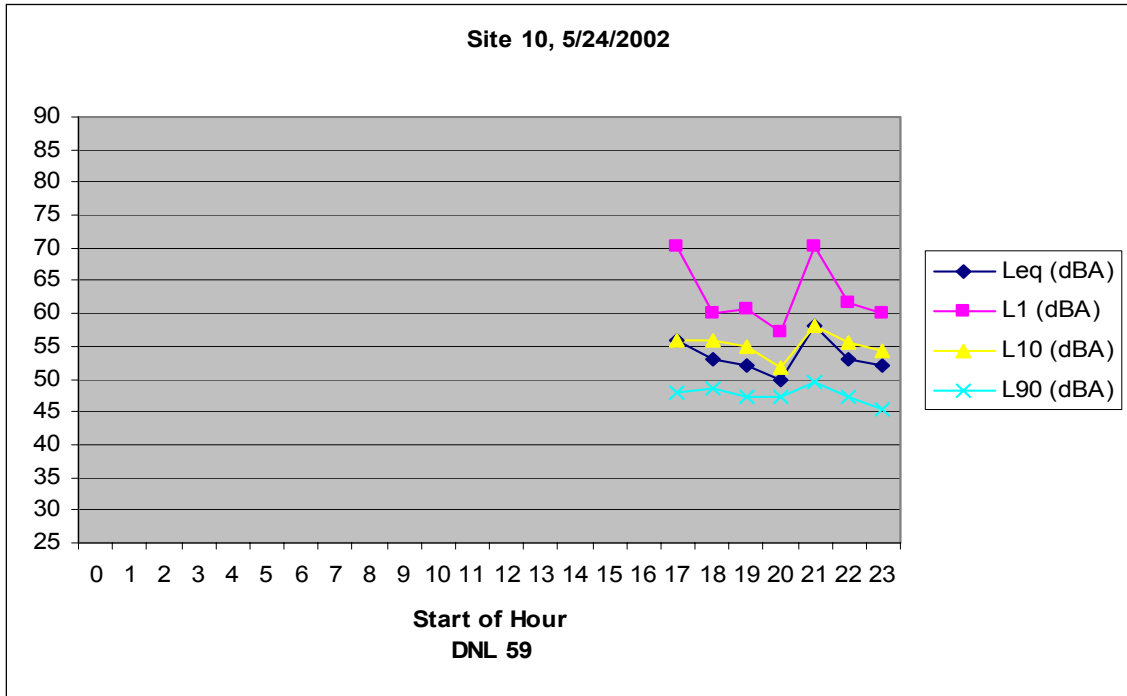
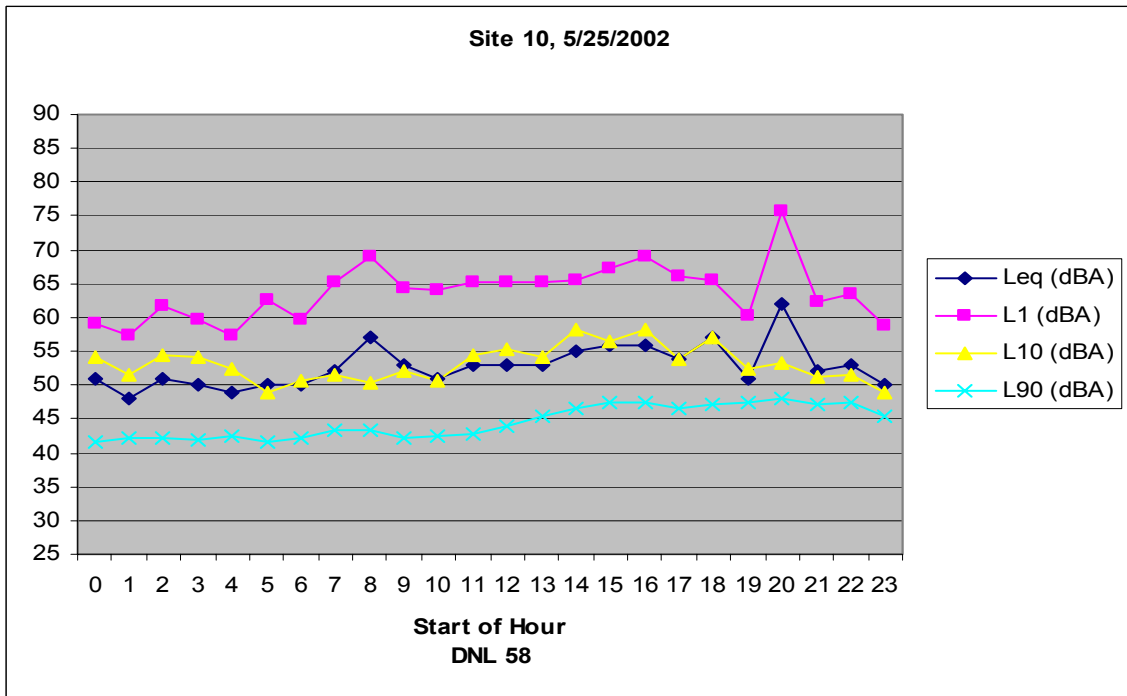
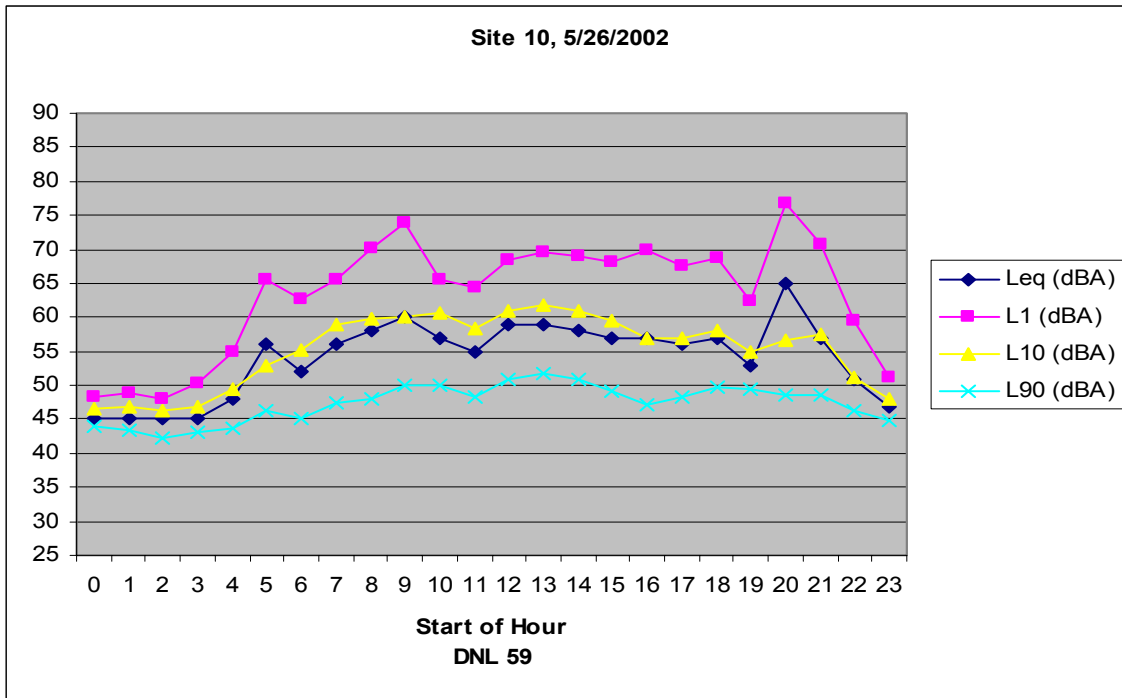
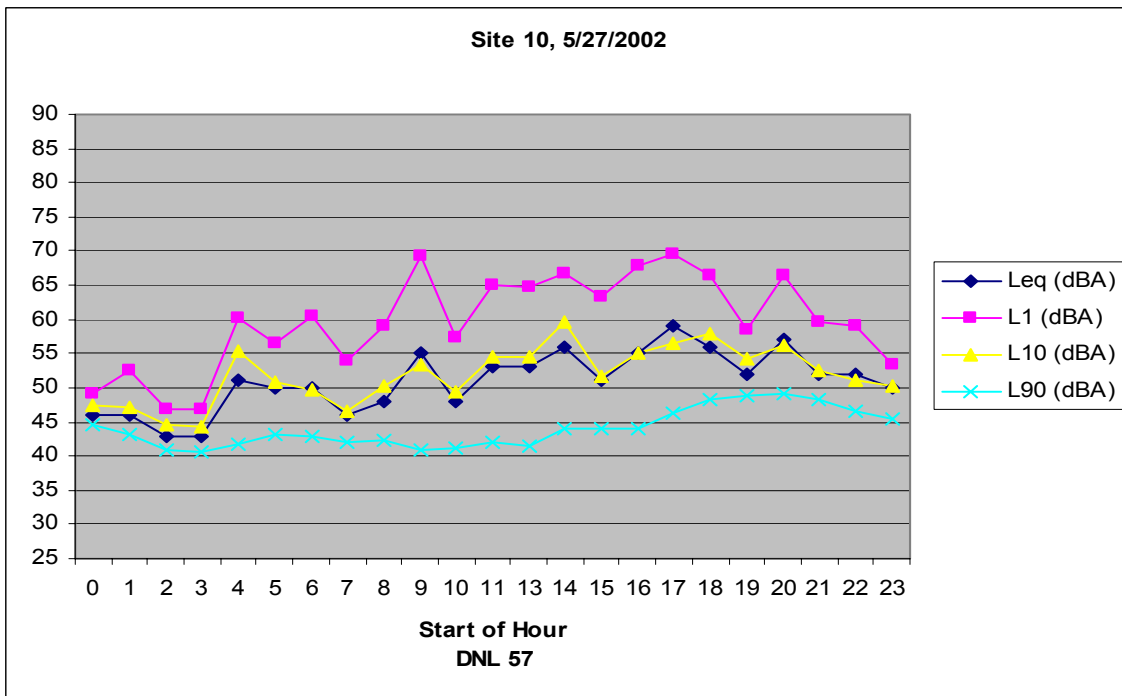
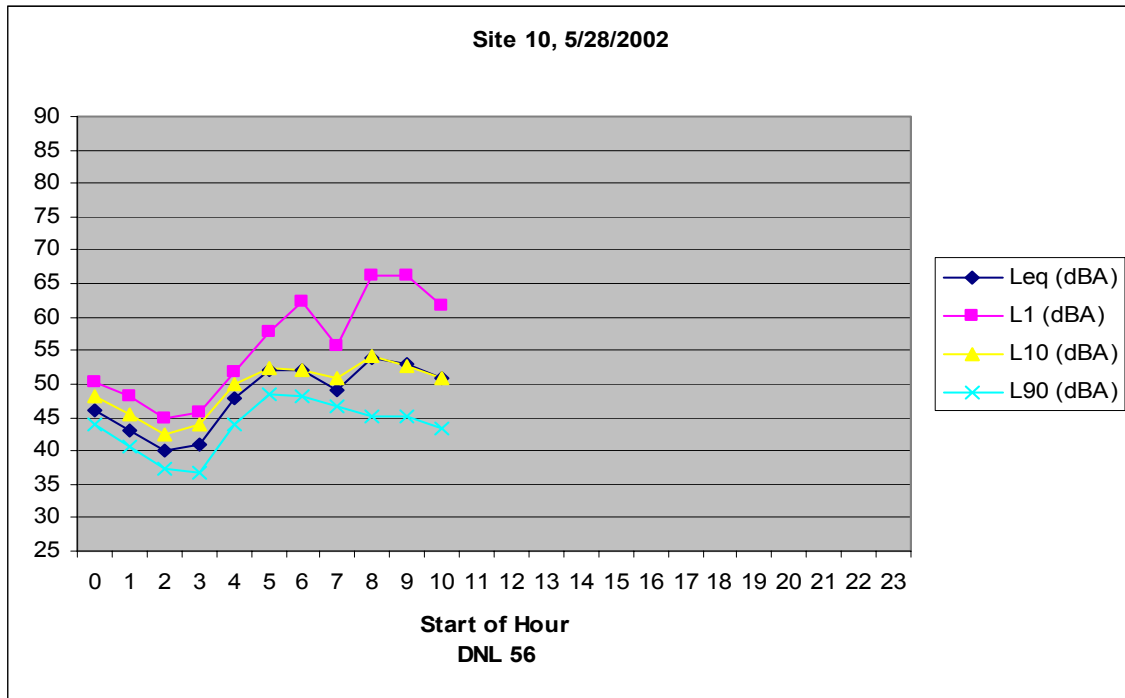
**Figure B-6 Measured Hourly Noise Levels, Site 10**

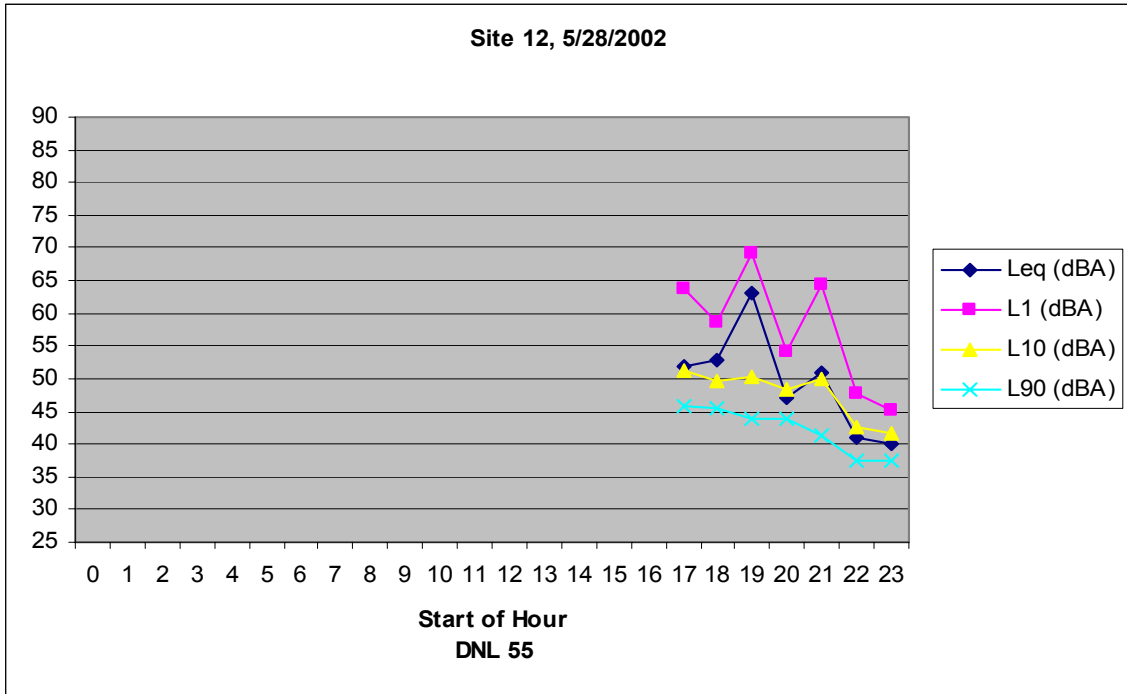
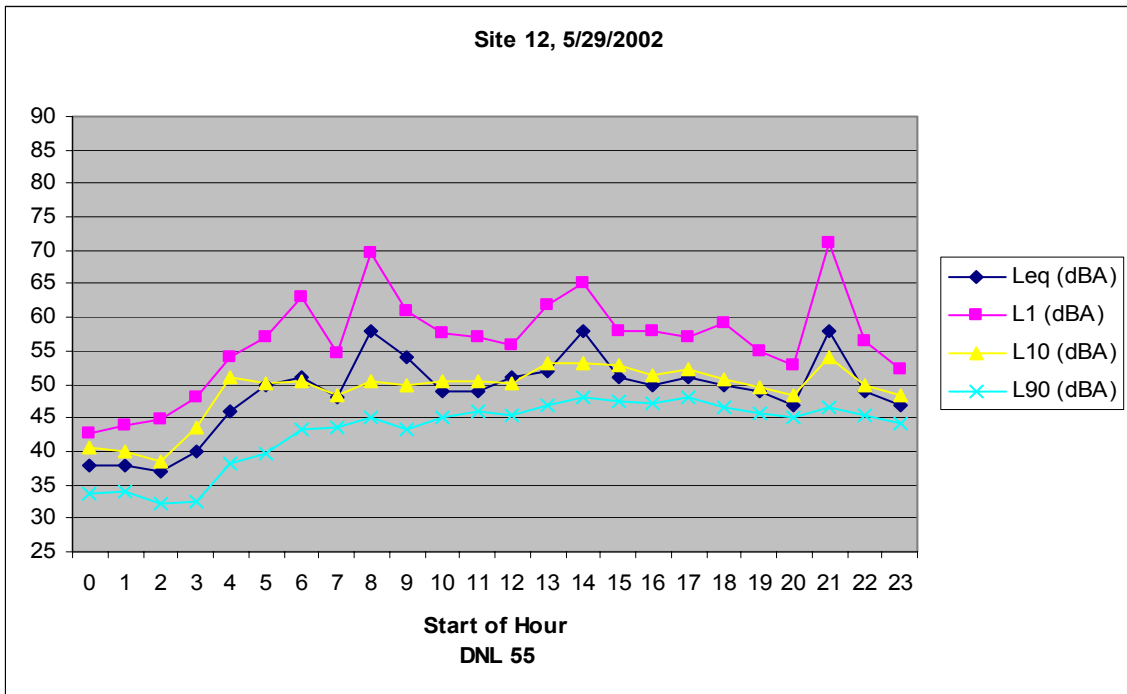
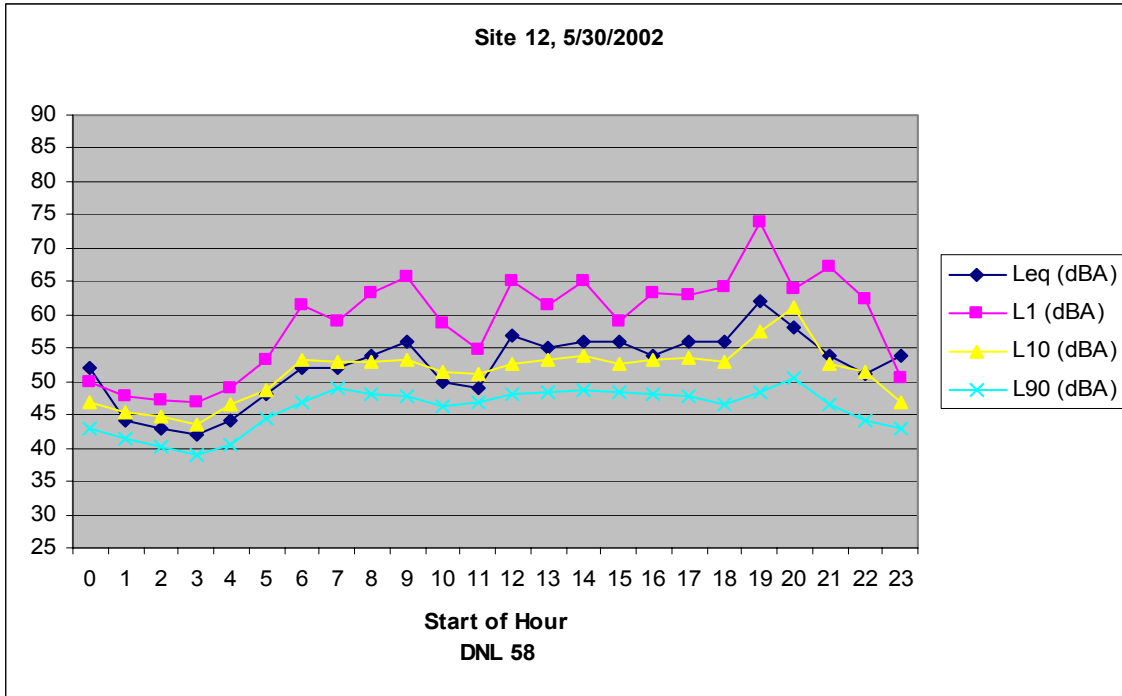
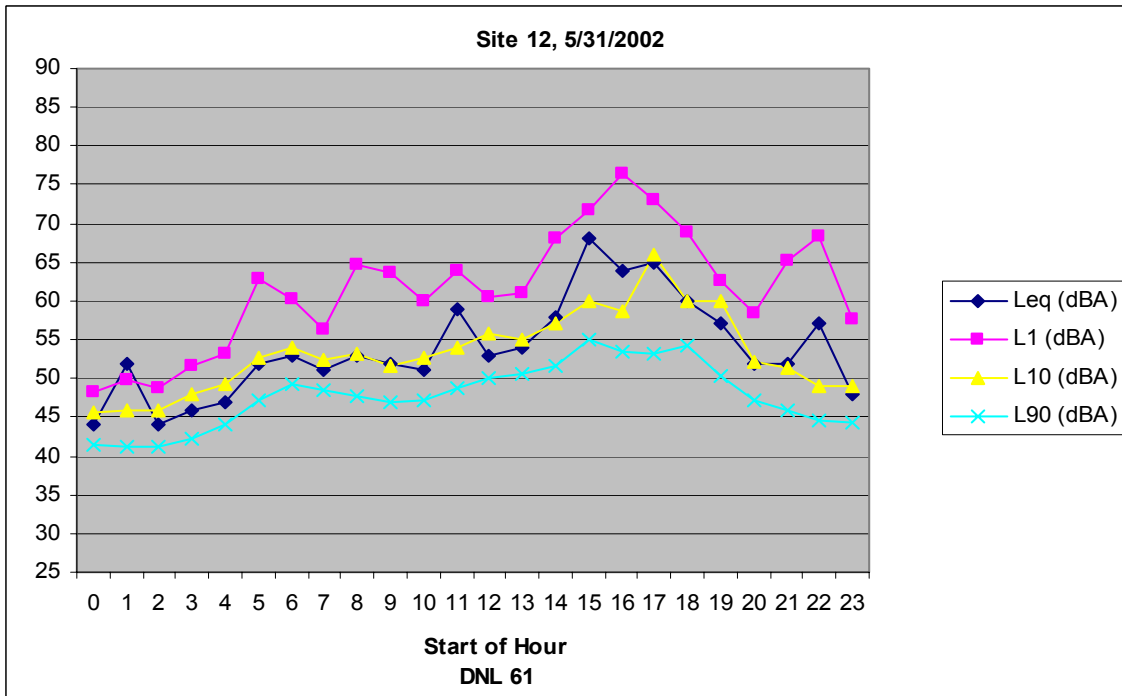
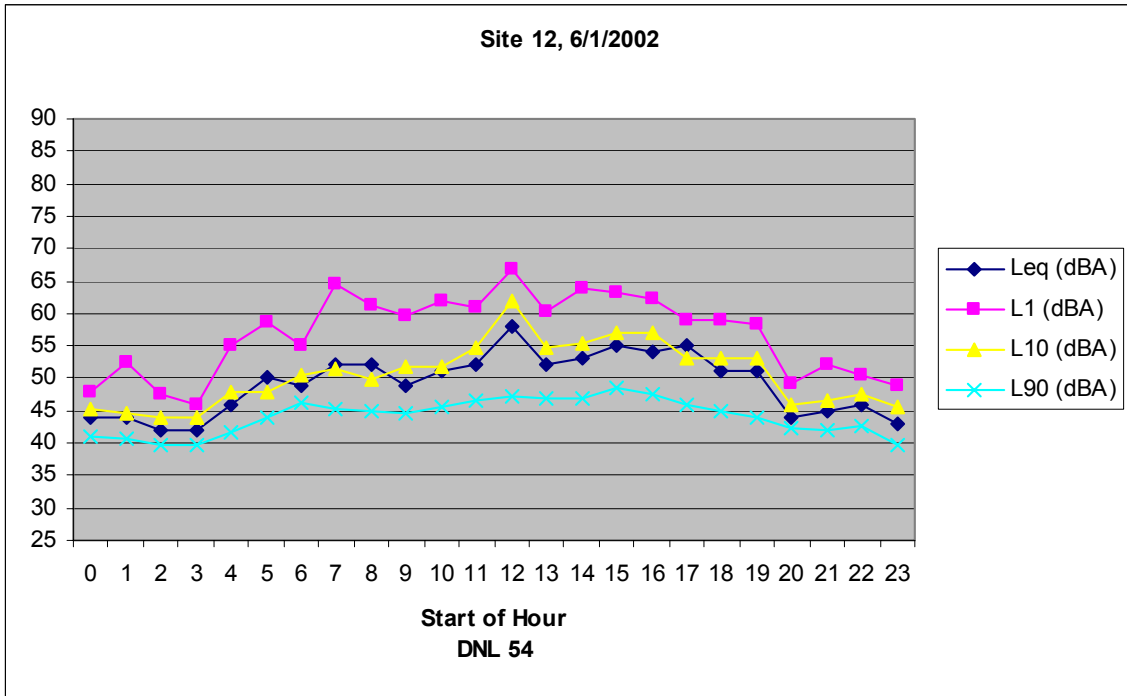
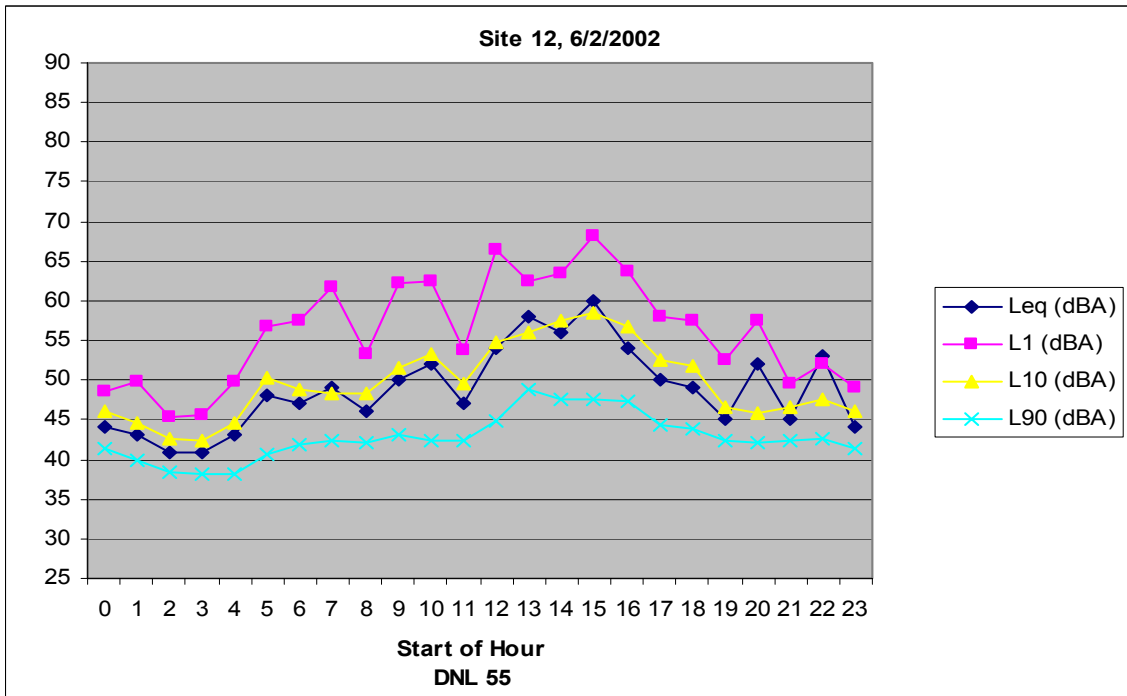
**Figure B-7 Measured Hourly Noise Levels, Site 12**

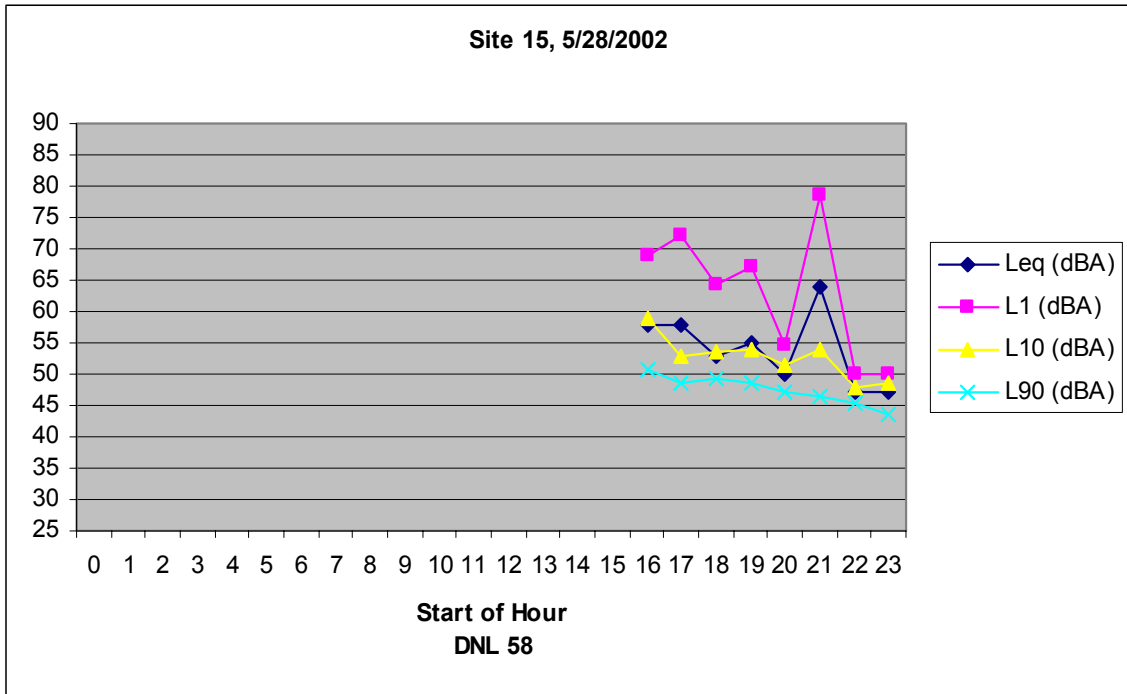
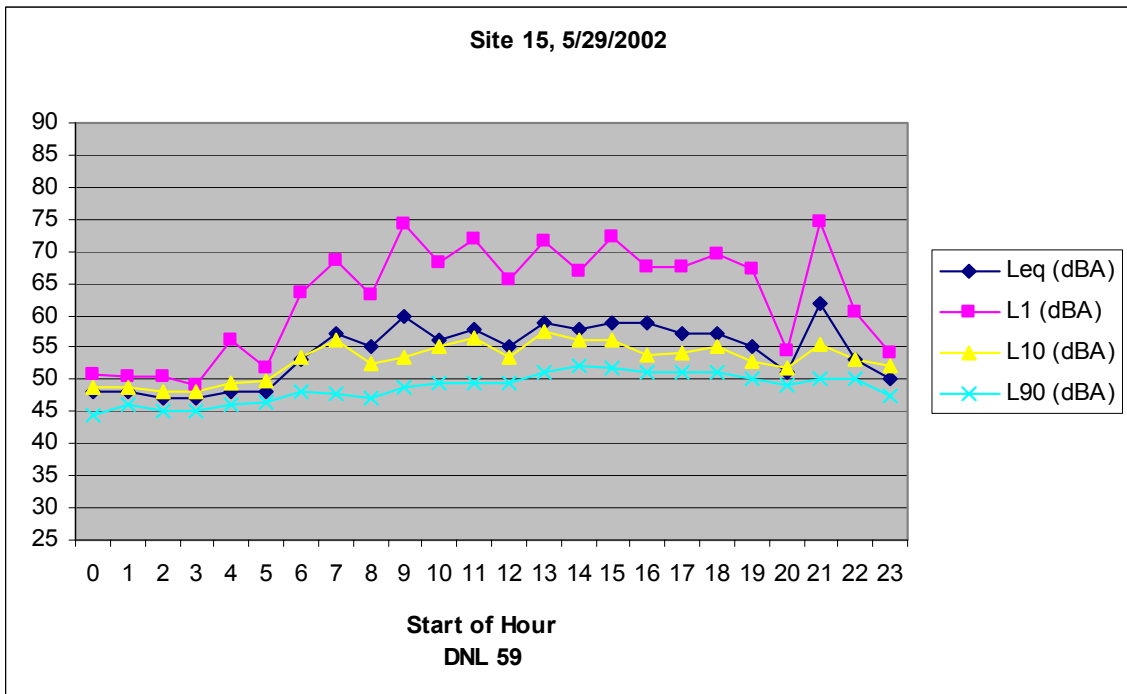
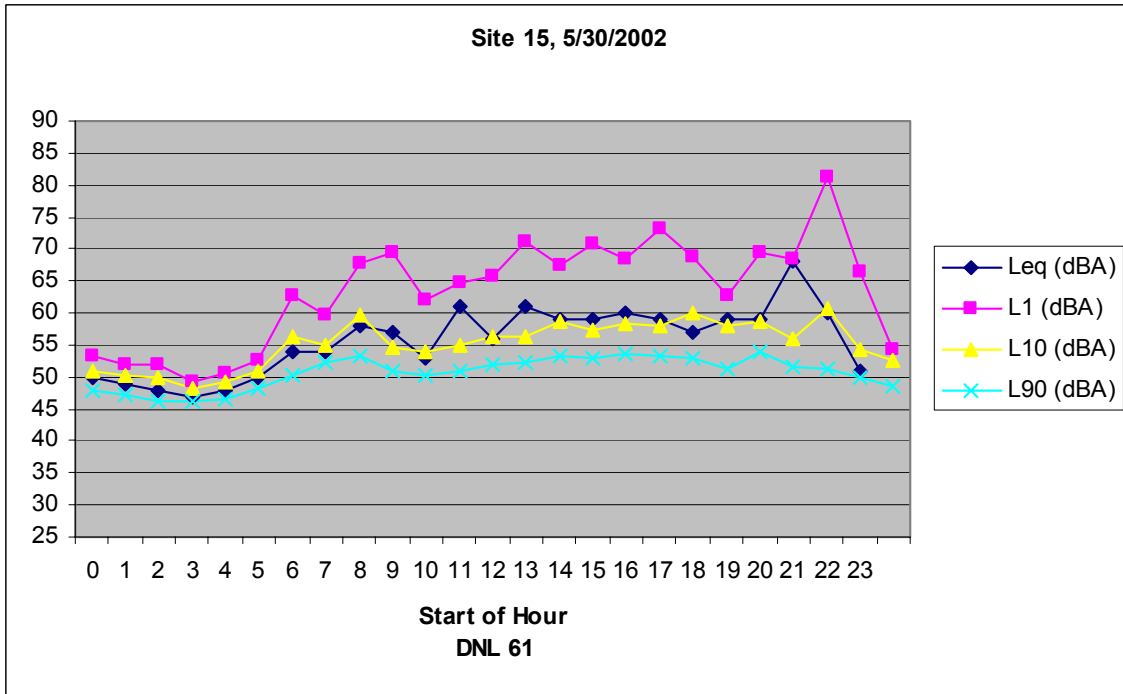
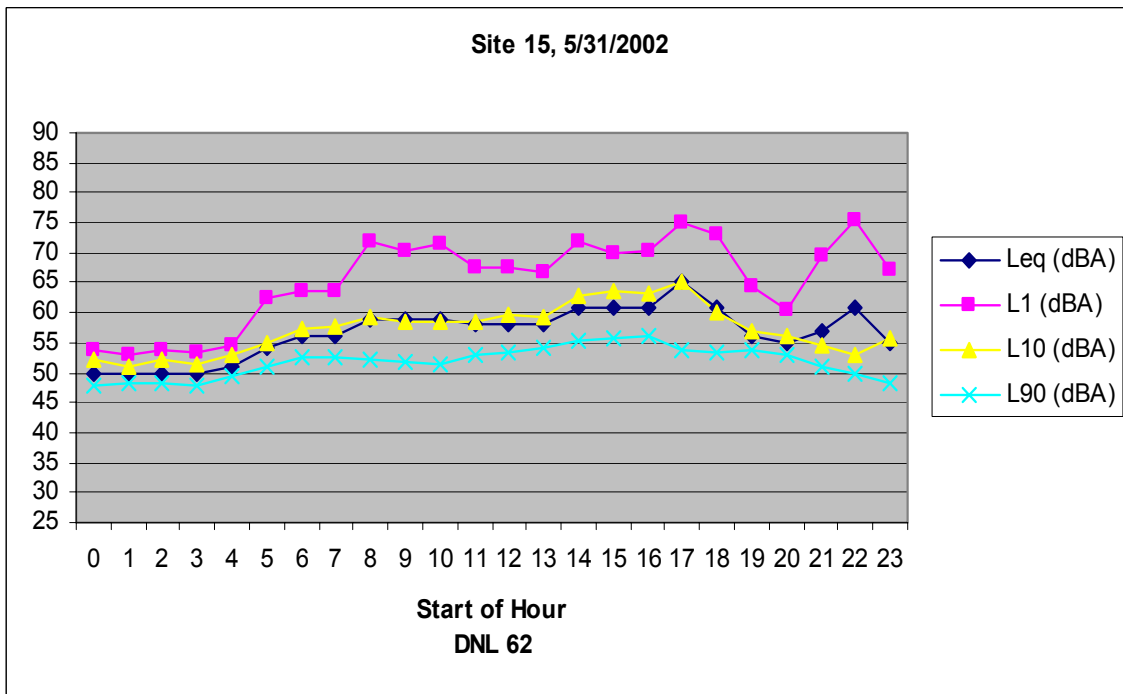
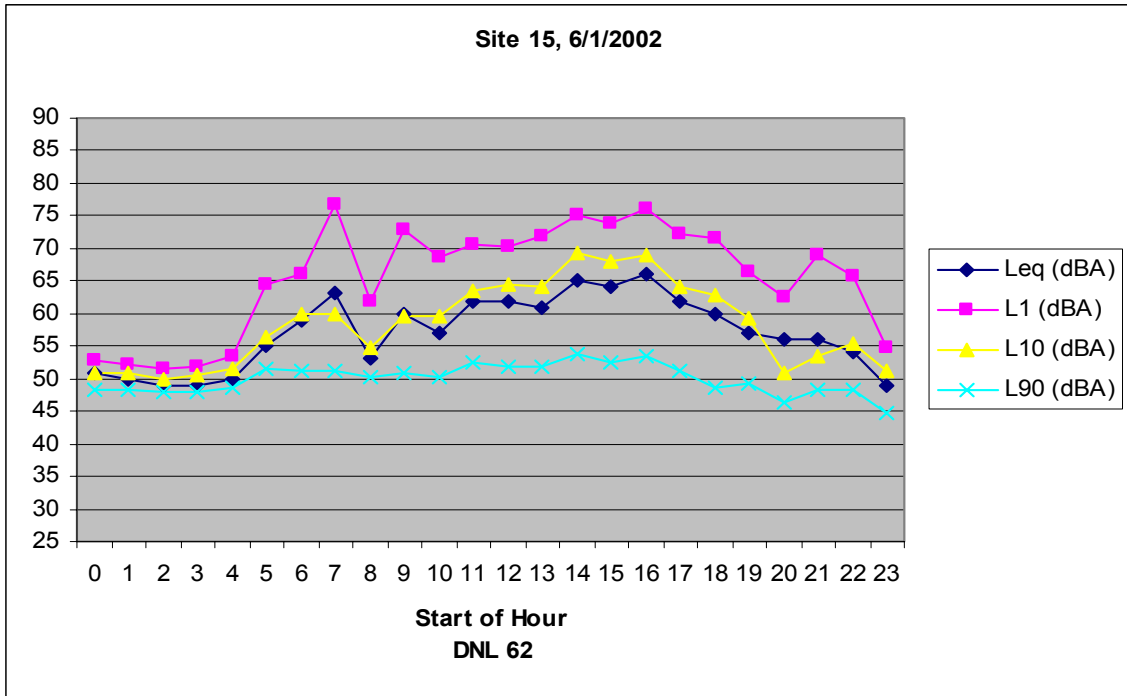
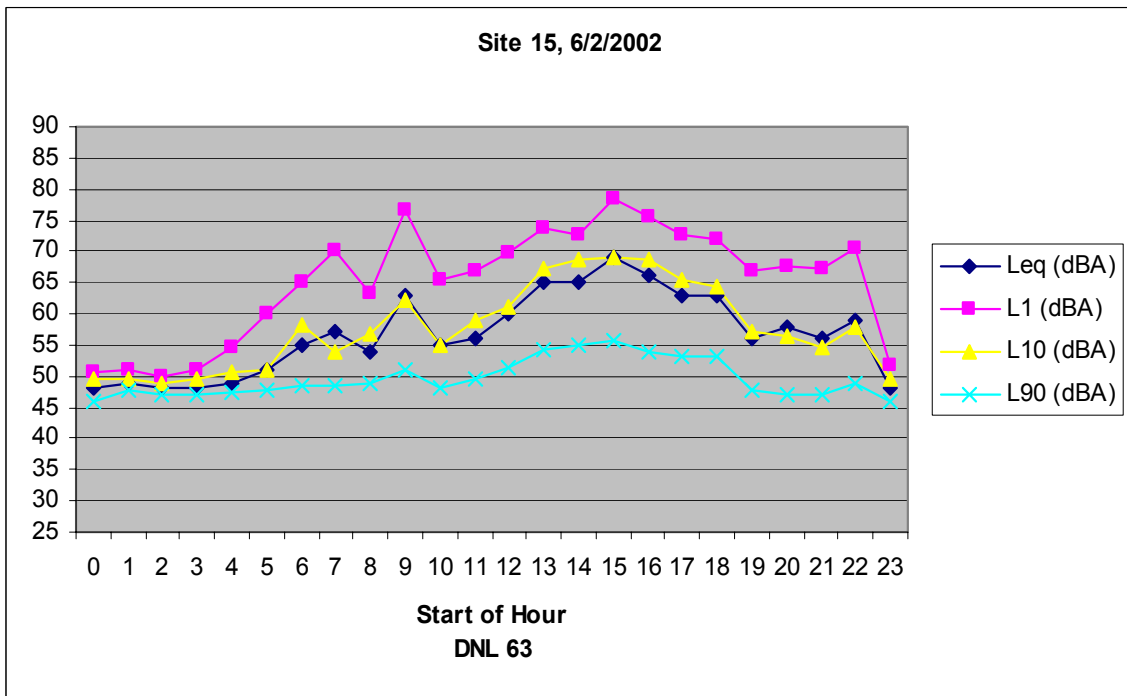
**Figure B-8 Measured Hourly Noise Levels, Site 15**

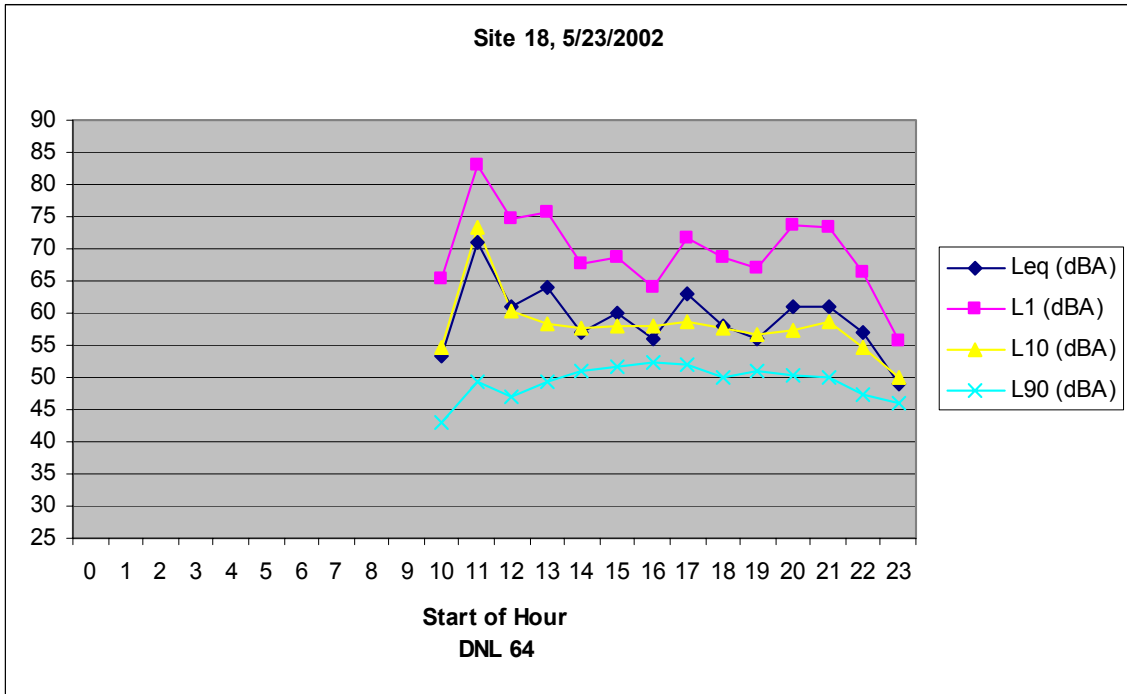
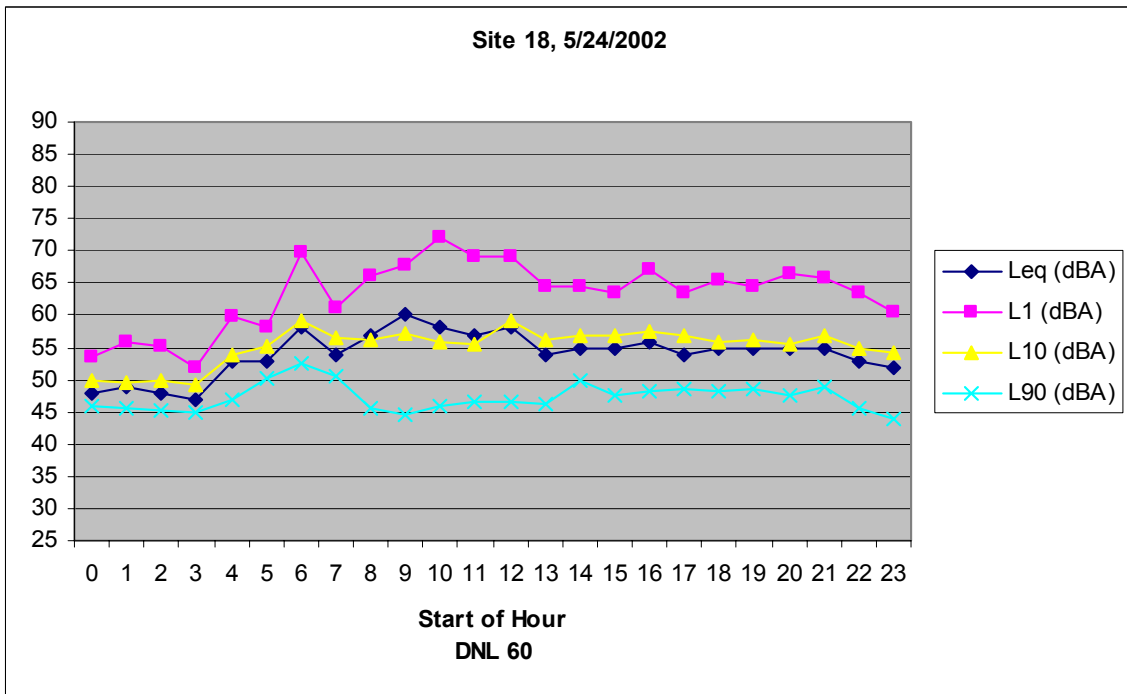
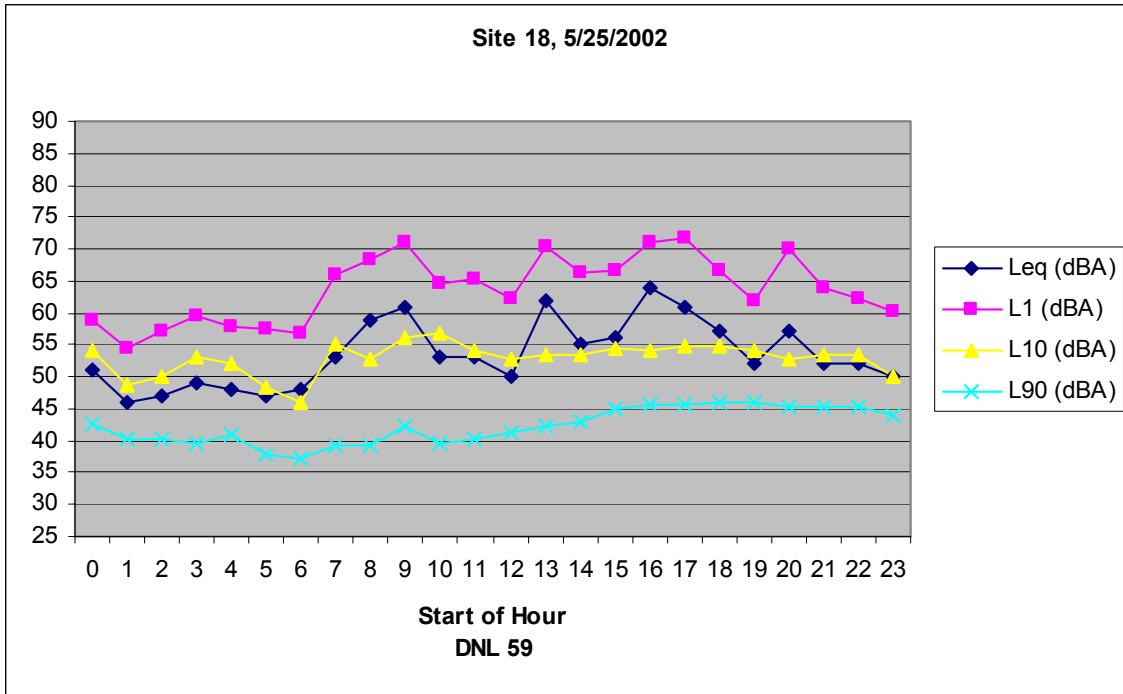
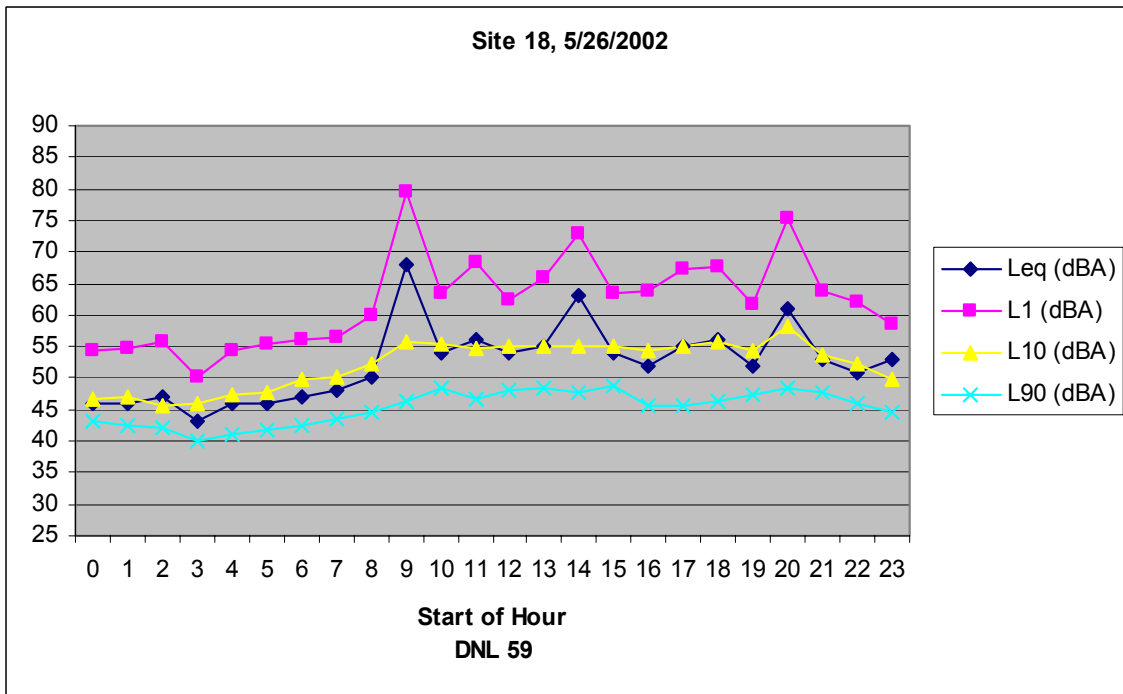
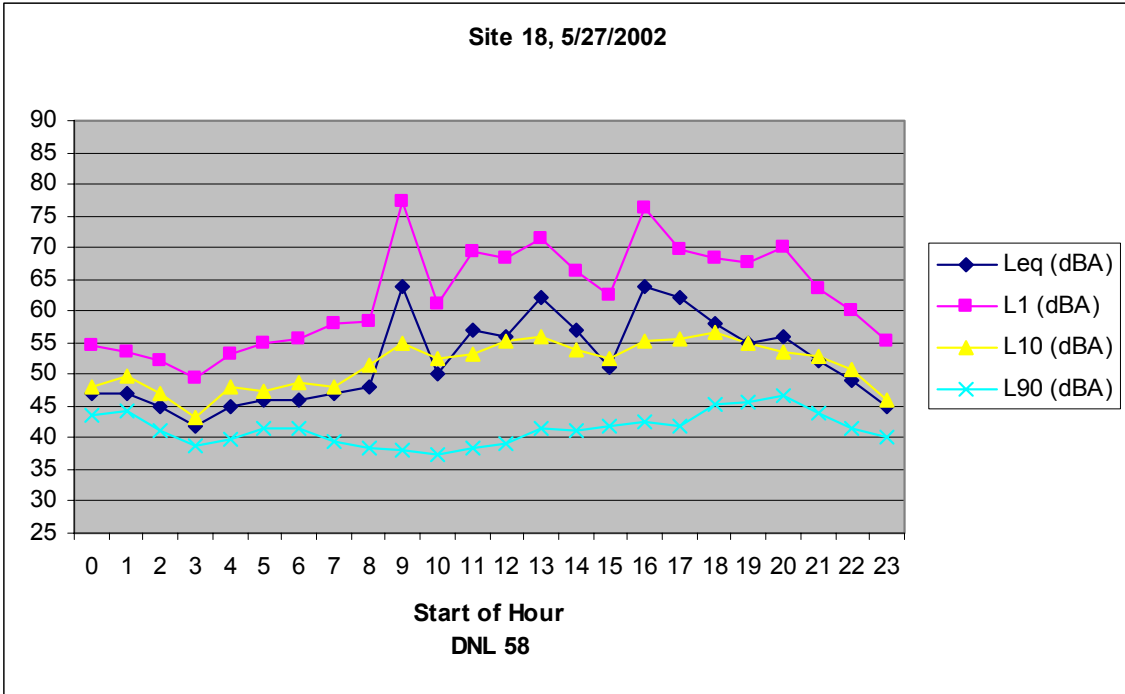
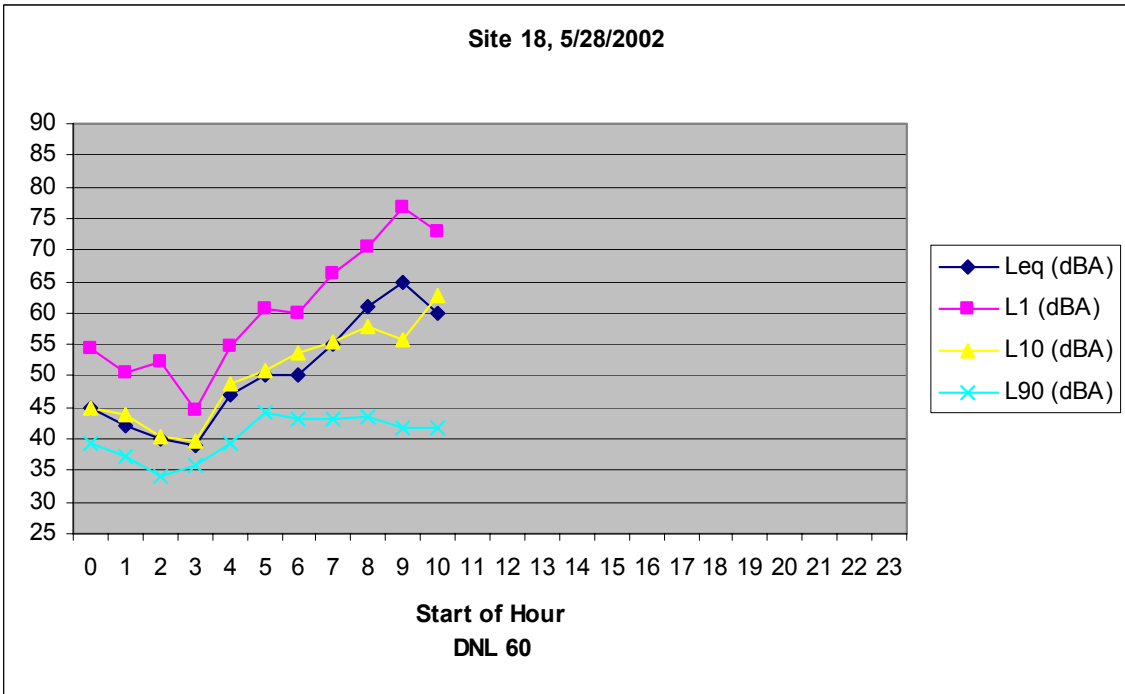
**Figure B-9 Measured Hourly Noise Levels, Site 18**

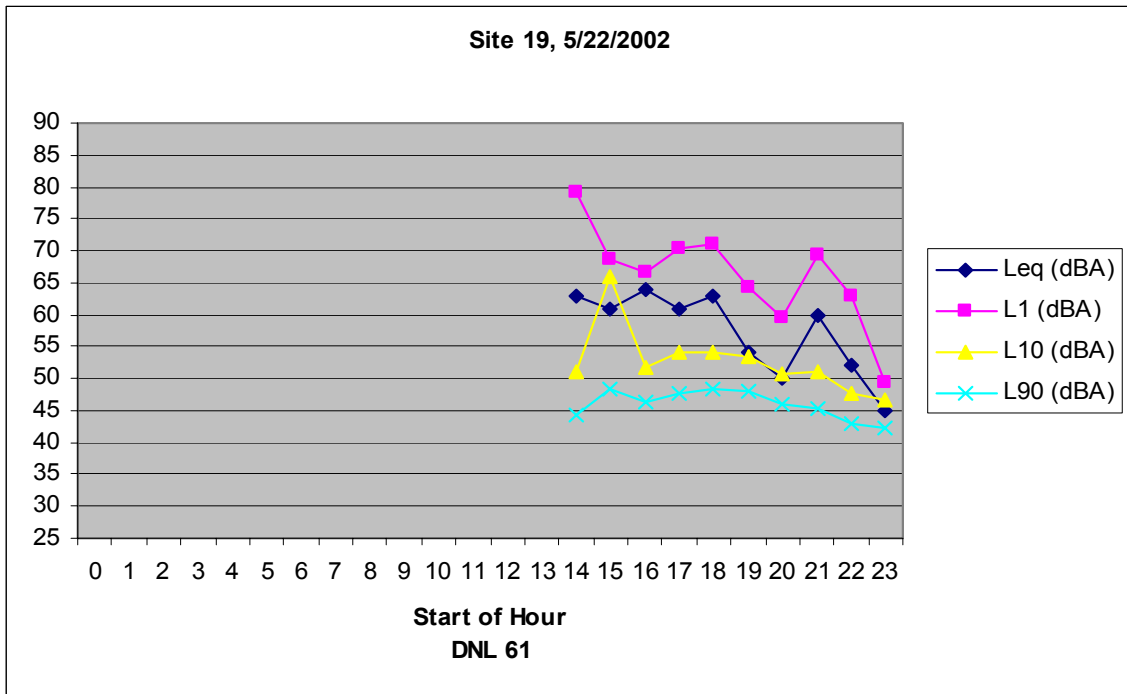
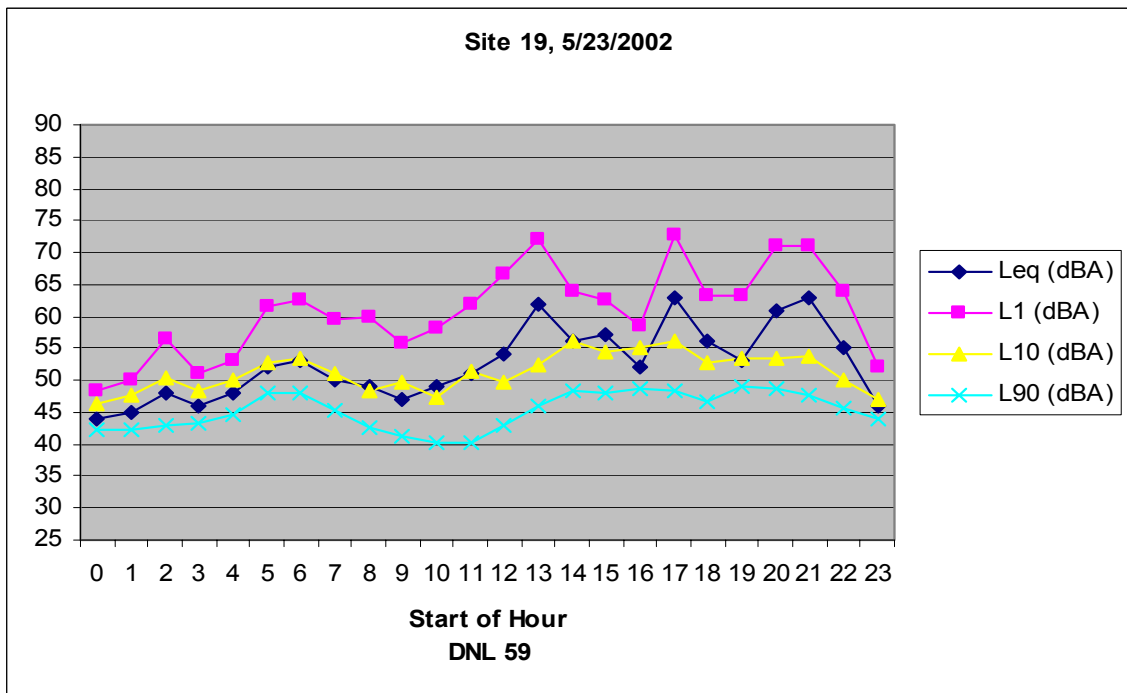
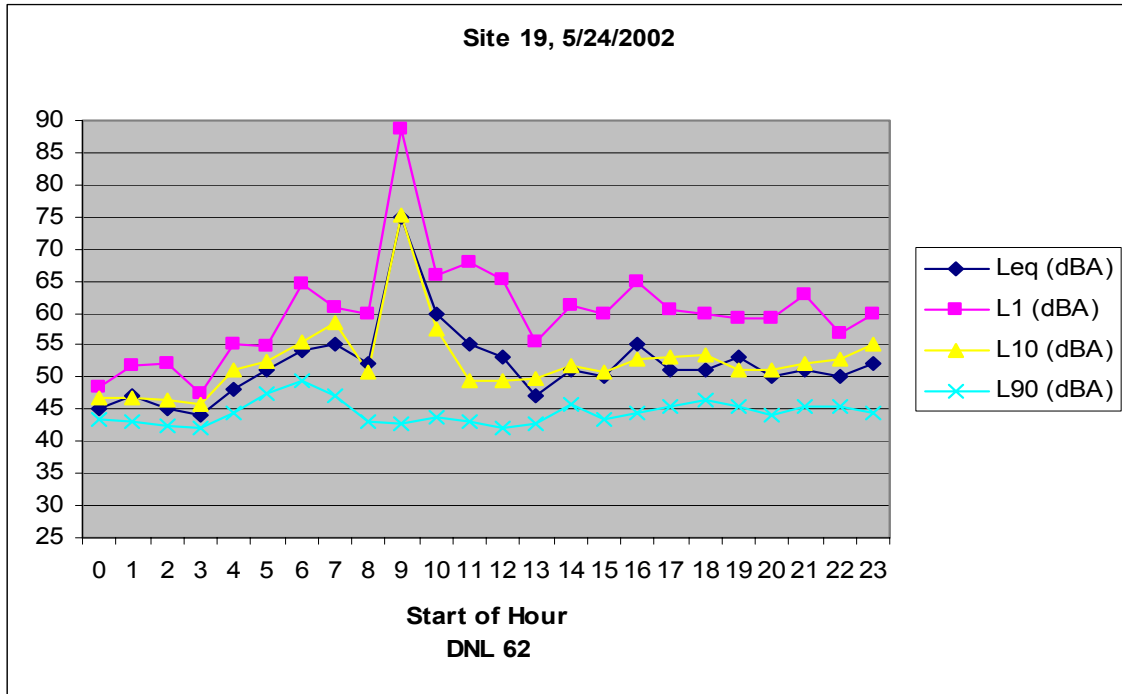
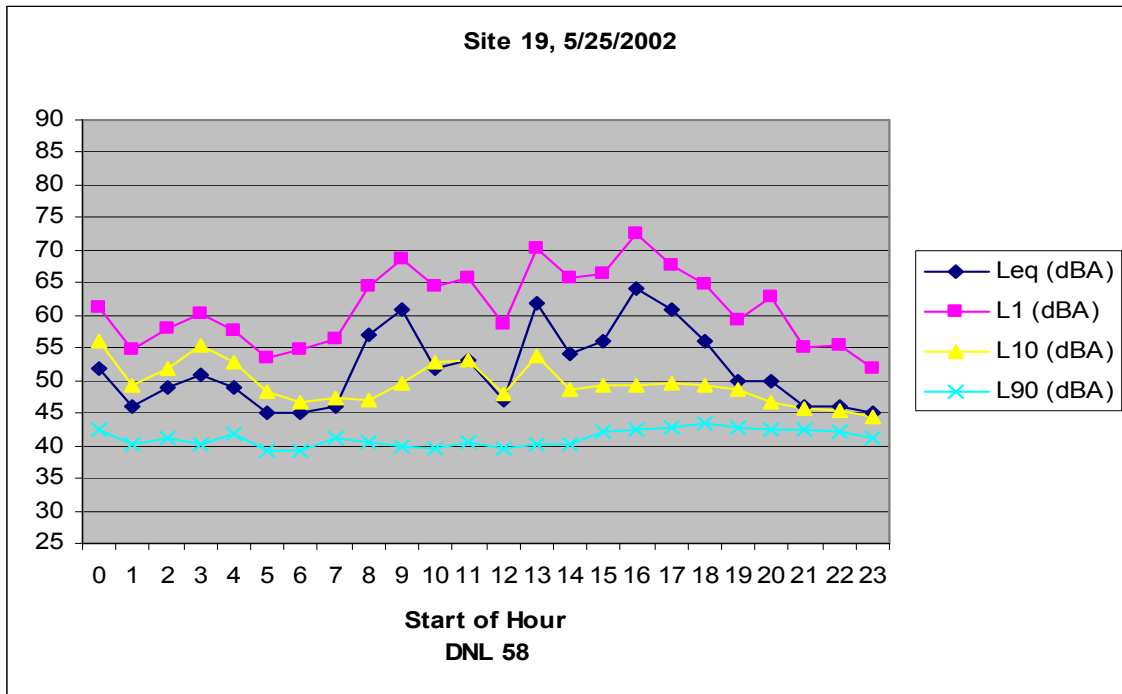
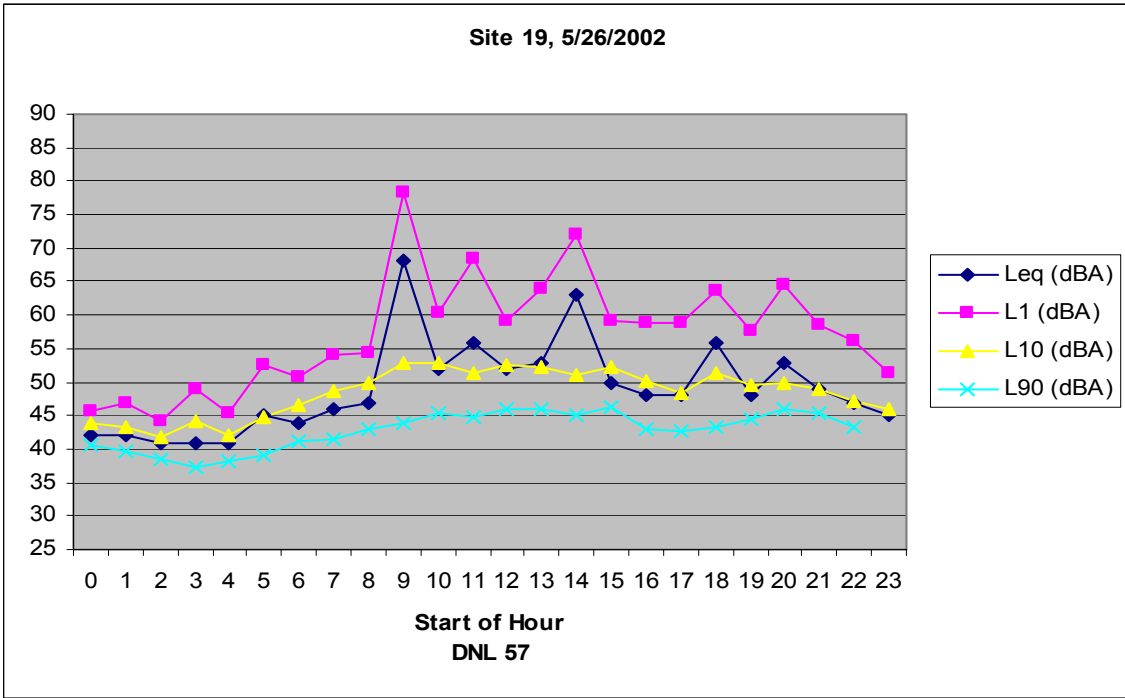
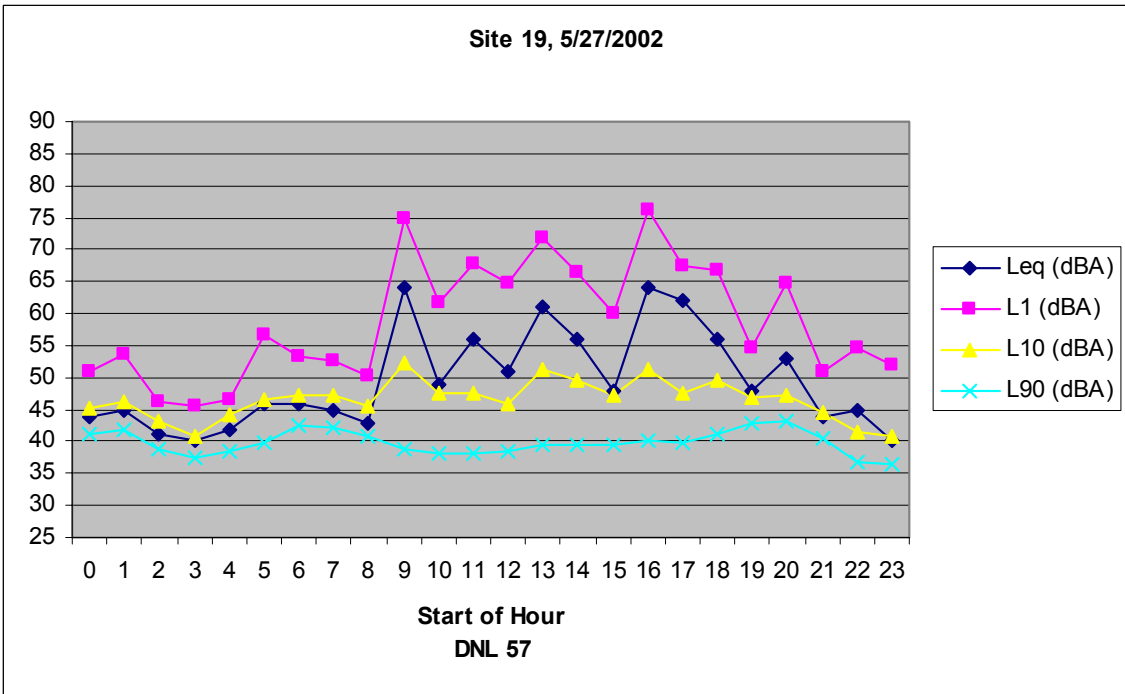
**Figure B-10 Measured Hourly Noise Levels, Site 19**
